## Reconnection, Restoration, Resilience

The 1.3-acre estuary at Meadowdale Beach Park is the first stream mouth restoration along Puget Sound—a strategic move to improve habitat and public safety along a 25-mile stretch of the BNSF Railway from Everett to Seattle.

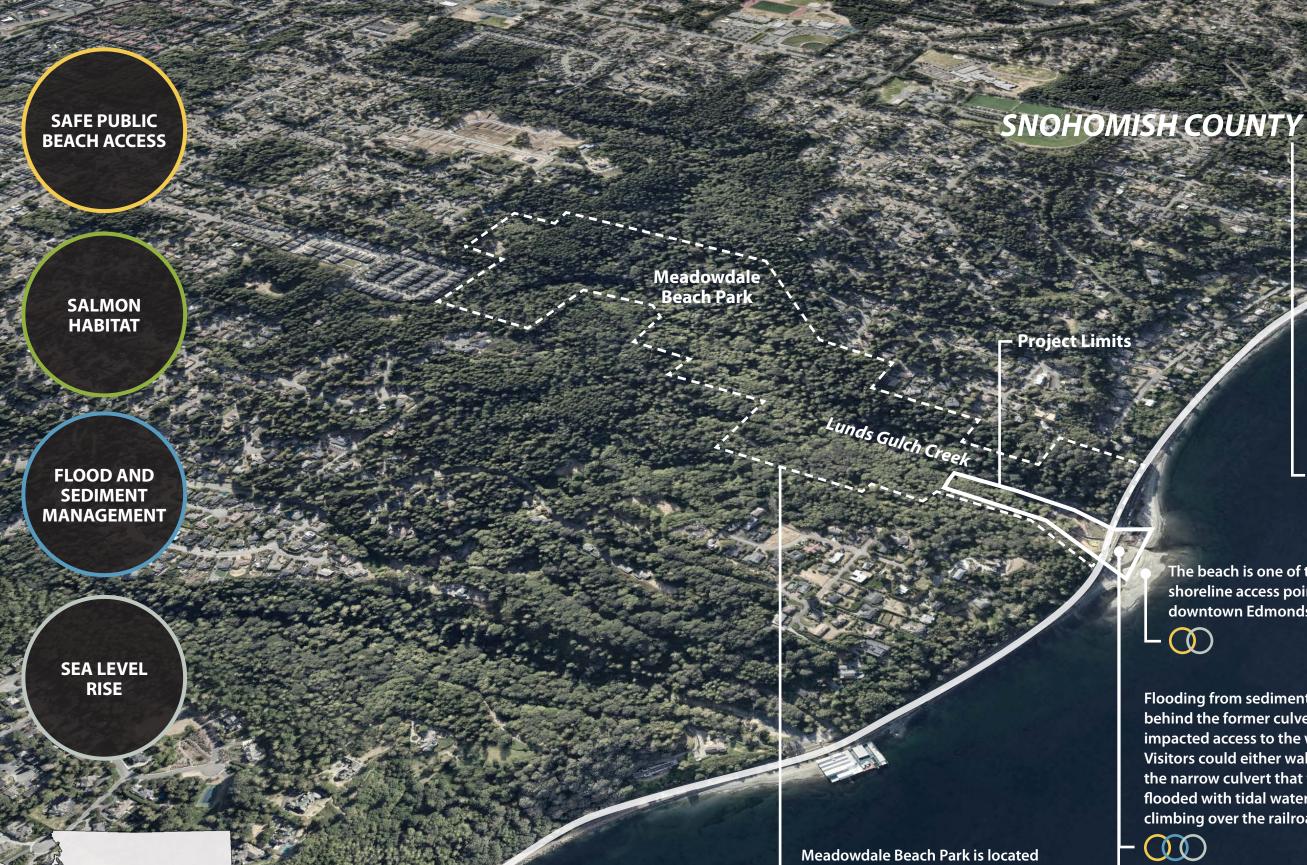
The BNSF railroad runs along 46 miles of Puget Sound shoreline. Construction of the railway berm impacted creeks and estuaries and resulted in hundreds of culverts to convey water.

within Lunds Gulch, a ravine with steep slopes, up to 40% grade. Steeps slopes cause frequent landslides and sediment buildup, an important ecological process to nourish shoreline beaches.

The beach is one of two public shoreline access points between downtown Edmonds and Mukilteo.

Flooding from sediment buildup behind the former culvert impacted access to the water. Visitors could either walk through the narrow culvert that was often flooded with tidal waters or risk climbing over the railroad tracks.

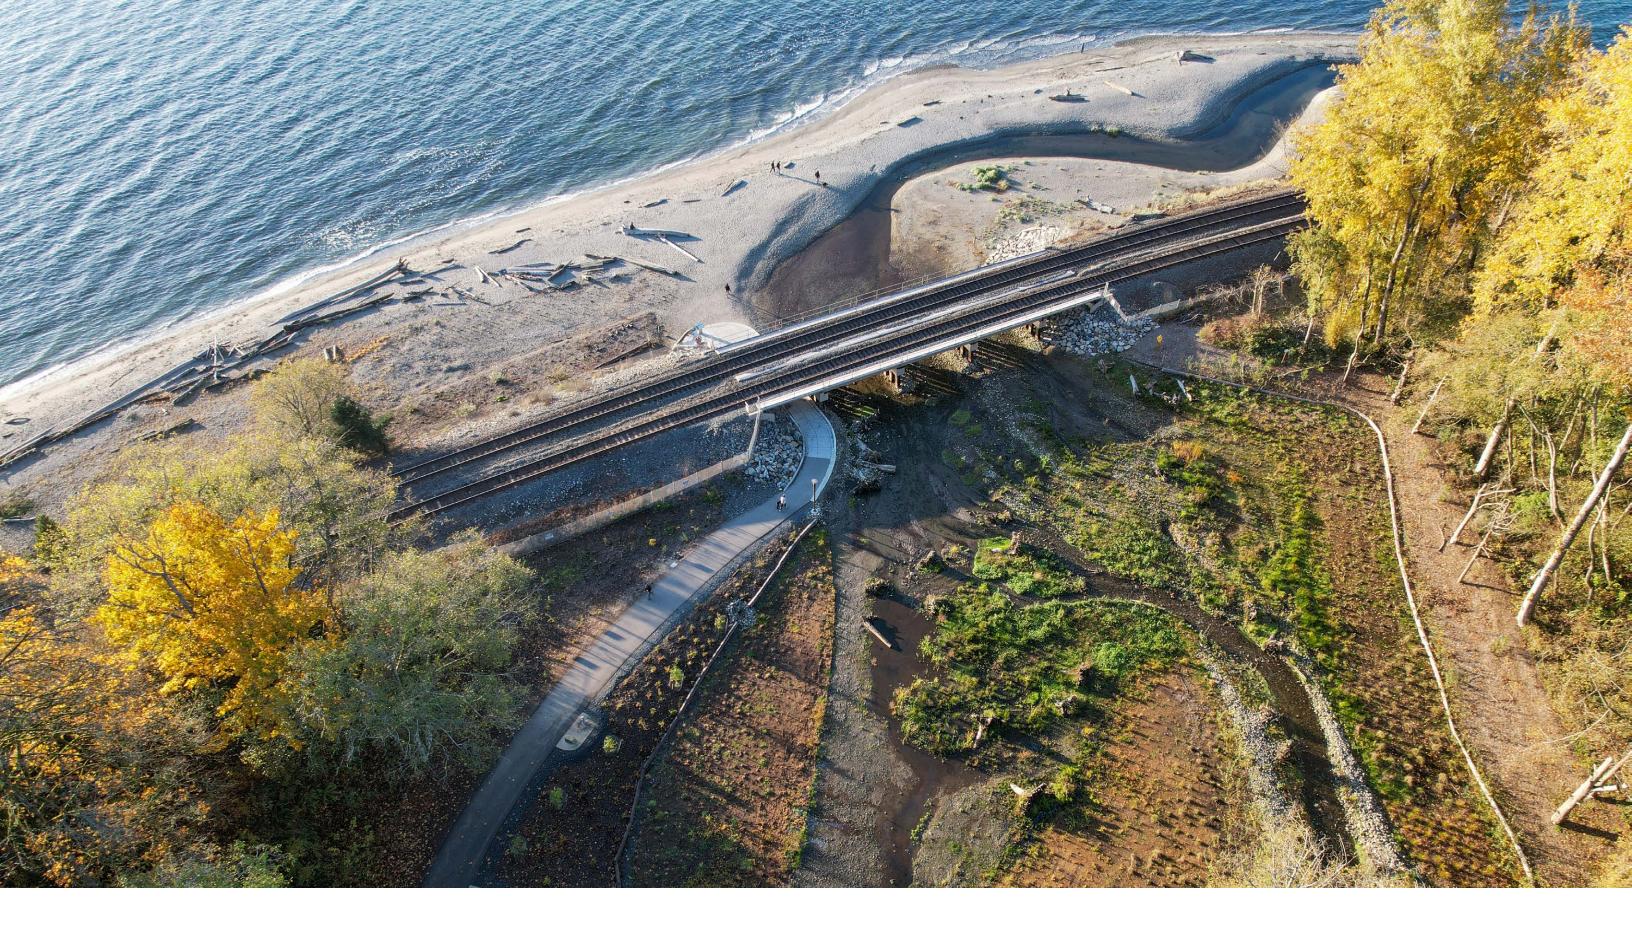
The restored estuary and lower creek freshwater habitats reintroduce shoreline coastal ecosystem processes including creek dynamic meandering, coastal wave influences on sediment transport and deposition, salt and freshwater development in brackish waters, and accumulation of detritus and wood.

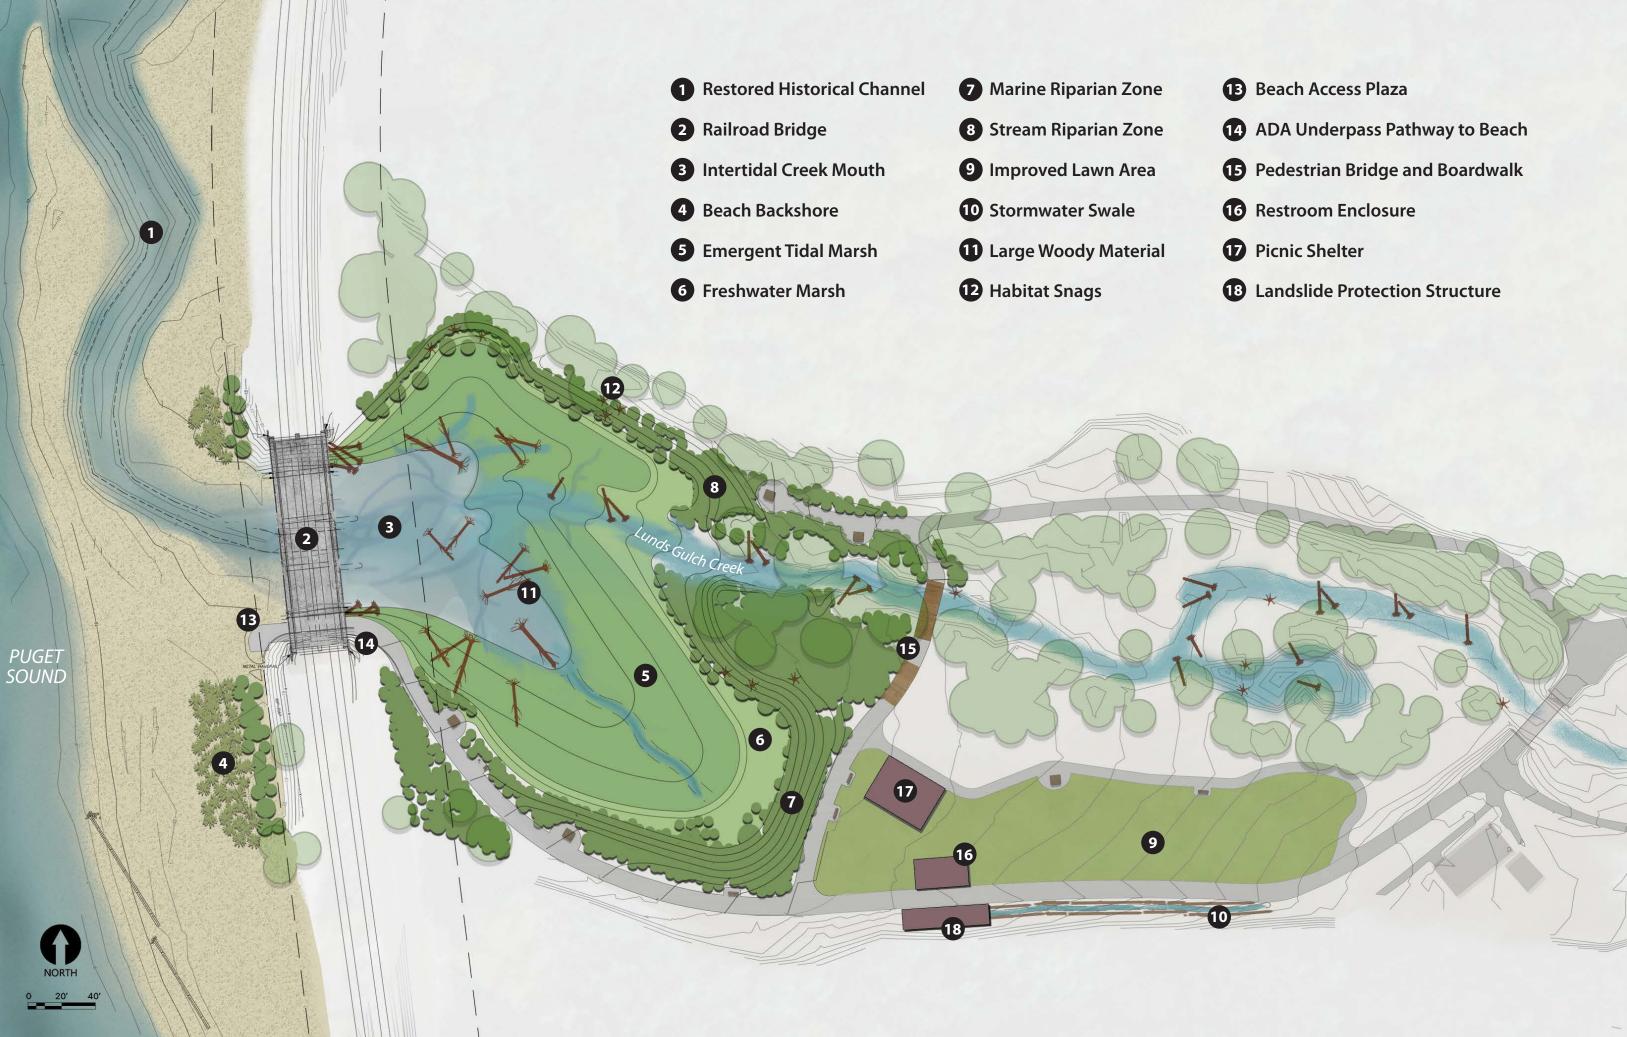
Once primarily a non-native grass lawn, the design reintroduces the landscape to native riparian and tidal plant communities. Plant communities were installed in habitat zones designed according to elevation and inundation frequency.

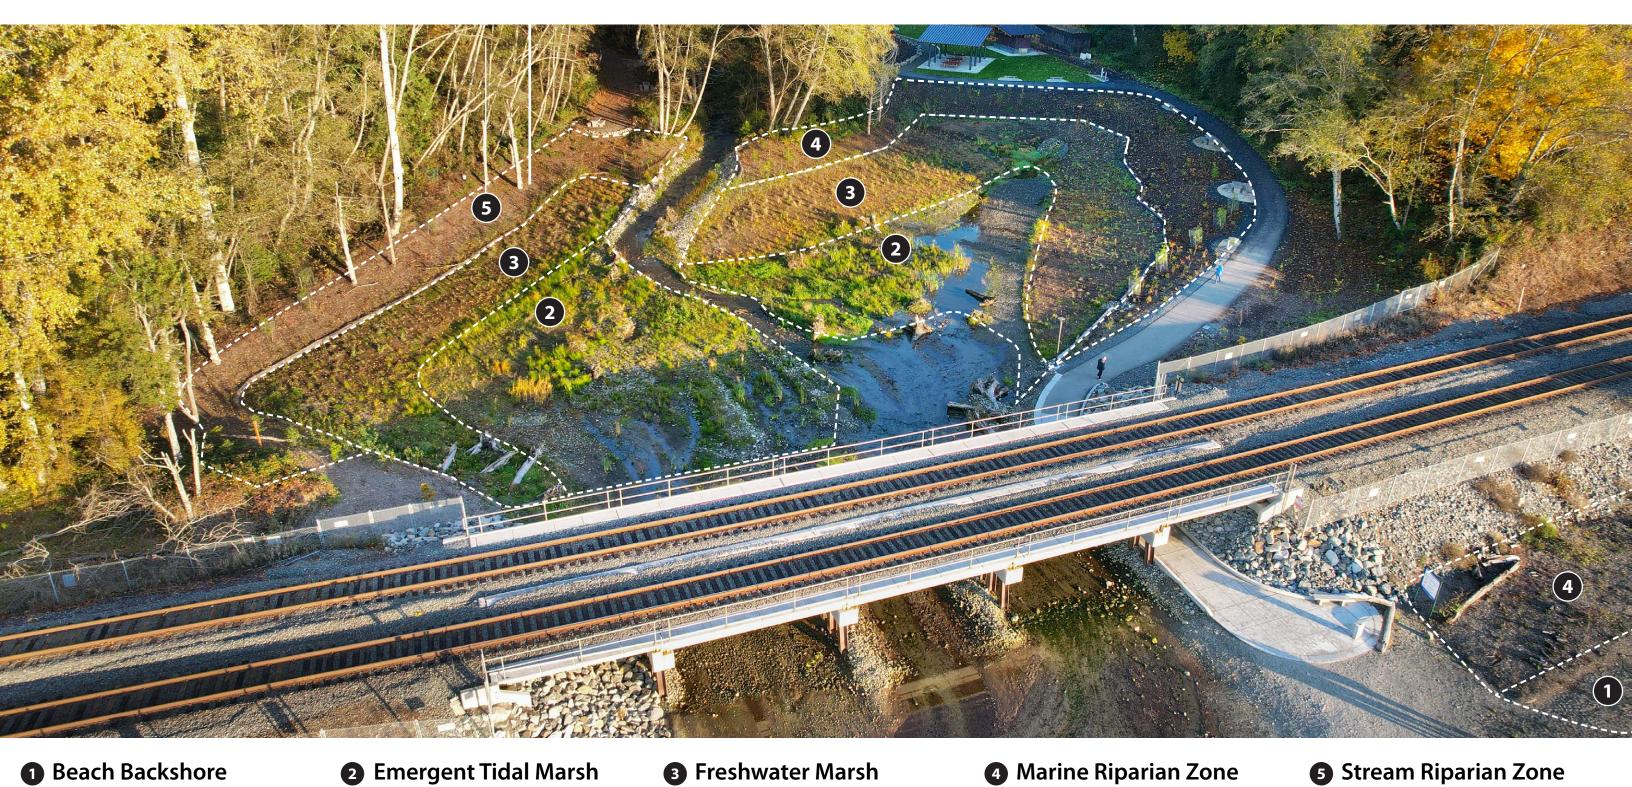
## Beach Backshore

# **4** Marine Riparian Zone

## **5** Stream Riparian Zone

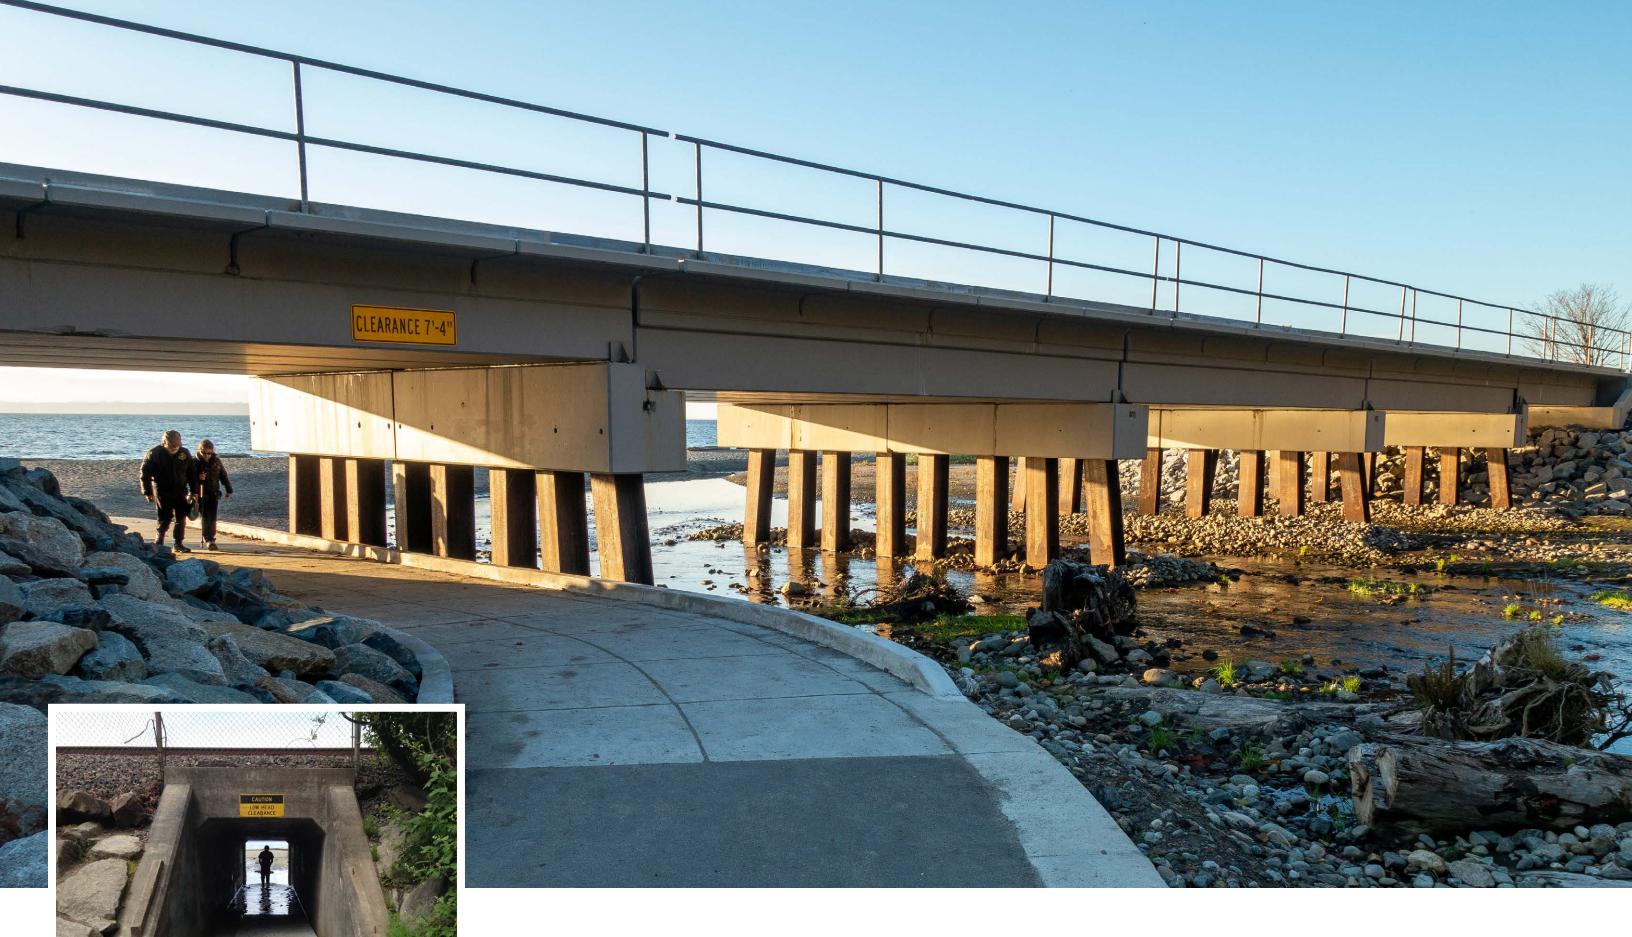
An ADA-compliant pathway under the railway bridge ensures safe access to the beach, free of deposited sediments and flood waters year-round that impacted the previously constricted underpass. It allows the visitor to be right at the center of a dynamic intersection of busy railroad traffic, daily high and low tides, and rush of Lunds Gulch Creek.

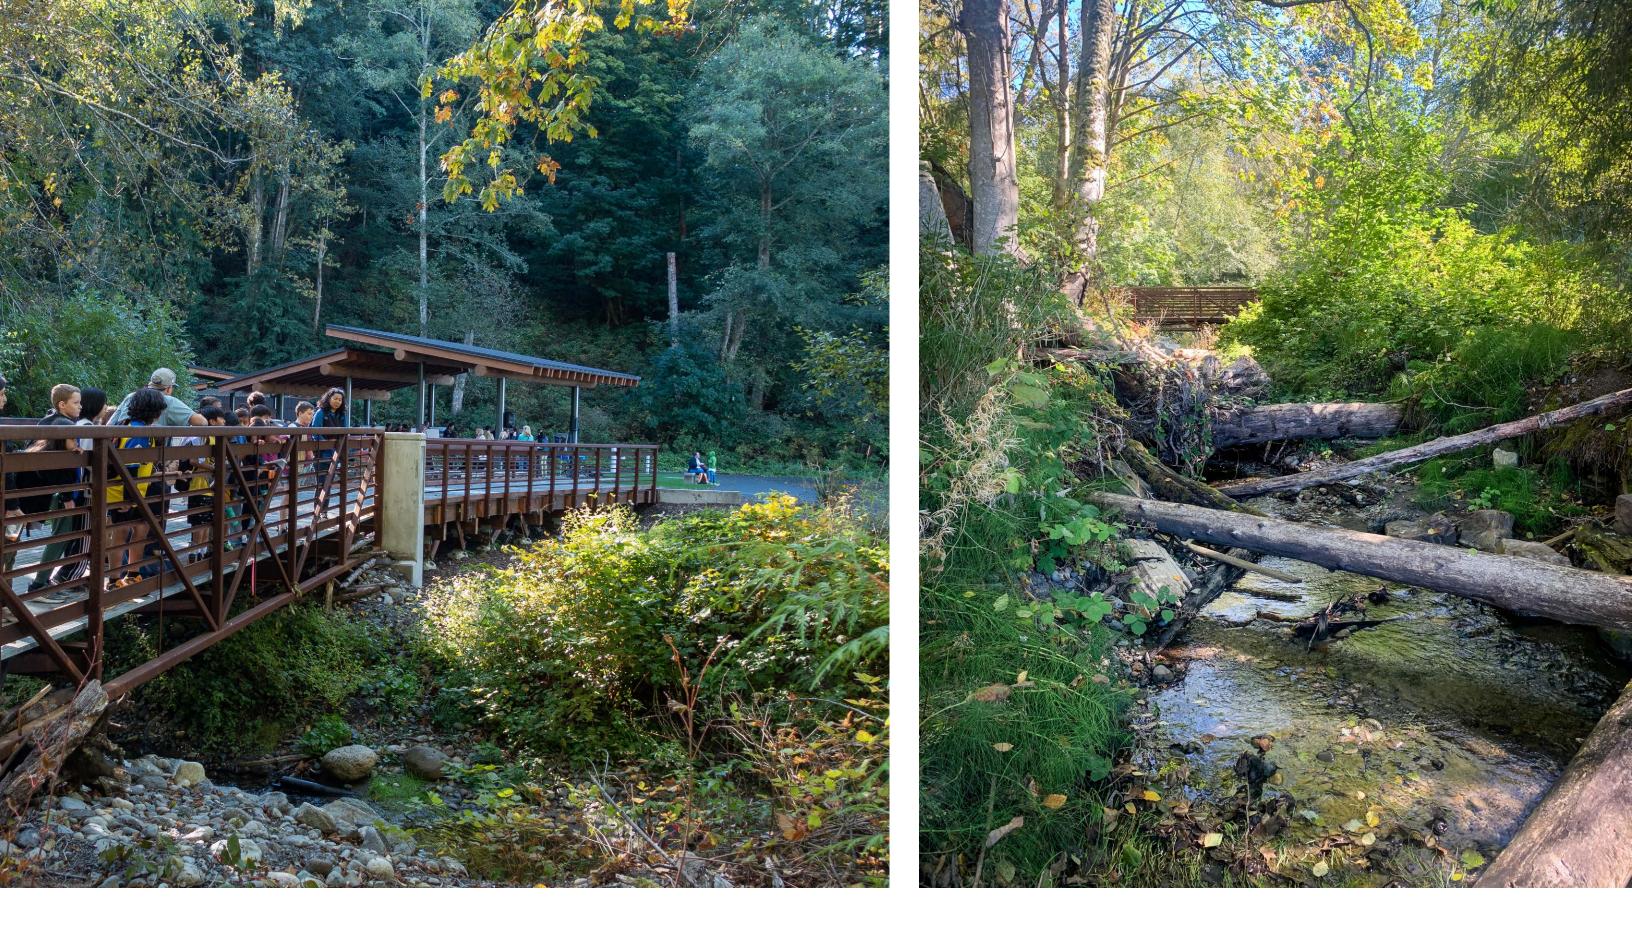
A new concrete and weathering steel pedestrian bridge traverses Lunds Gulch Creek to connect the upper and lower sections of the park and provide views of the salmon-bearing creek. Salvaged trees are used as large woody material and habitat snags throughout the creek and estuary to improve fish habitat.

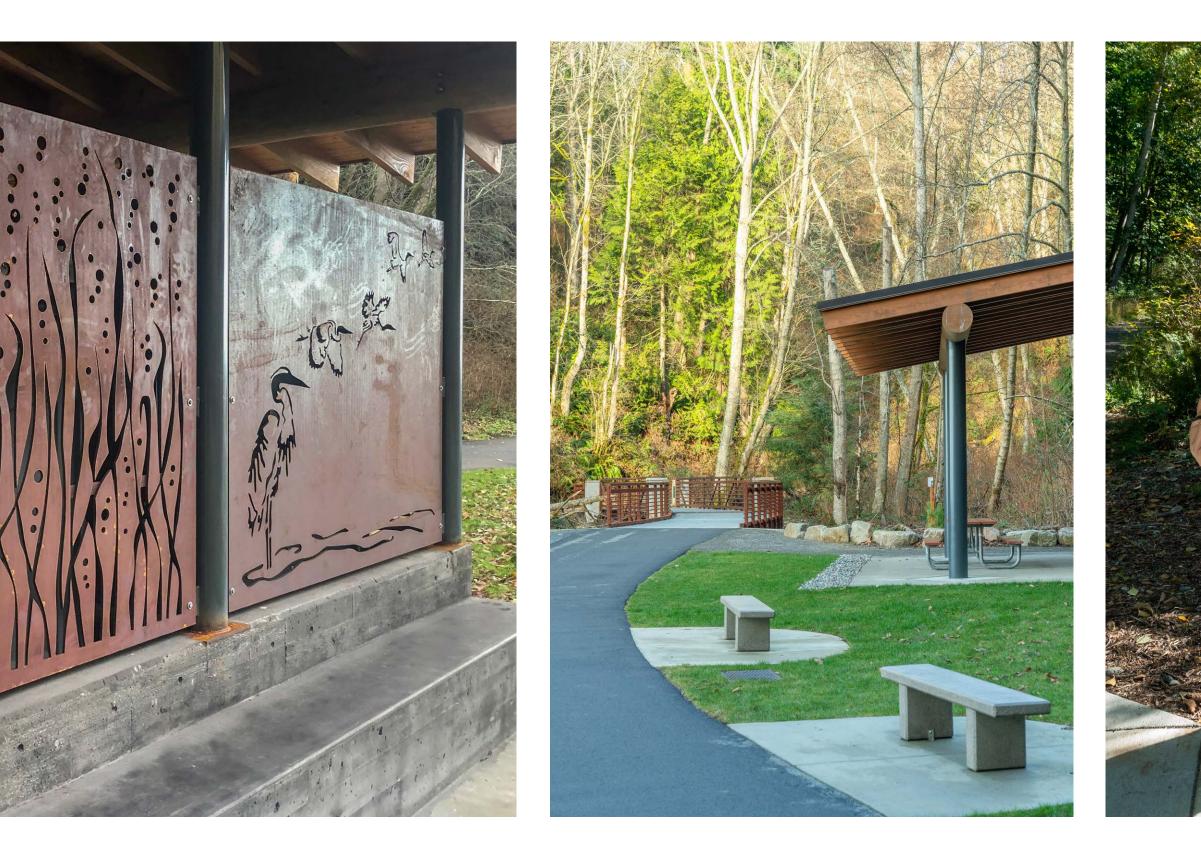
Material selection for the renovated path, benches, and structures prioritize long-term sustainability. The selected concrete, weathering steel, and asphalt are durable and will perform well in the rainy Western Washington climate. A simple palette complements the forested ravine, cobble, vegetated estuary, and other organic elements of the park.

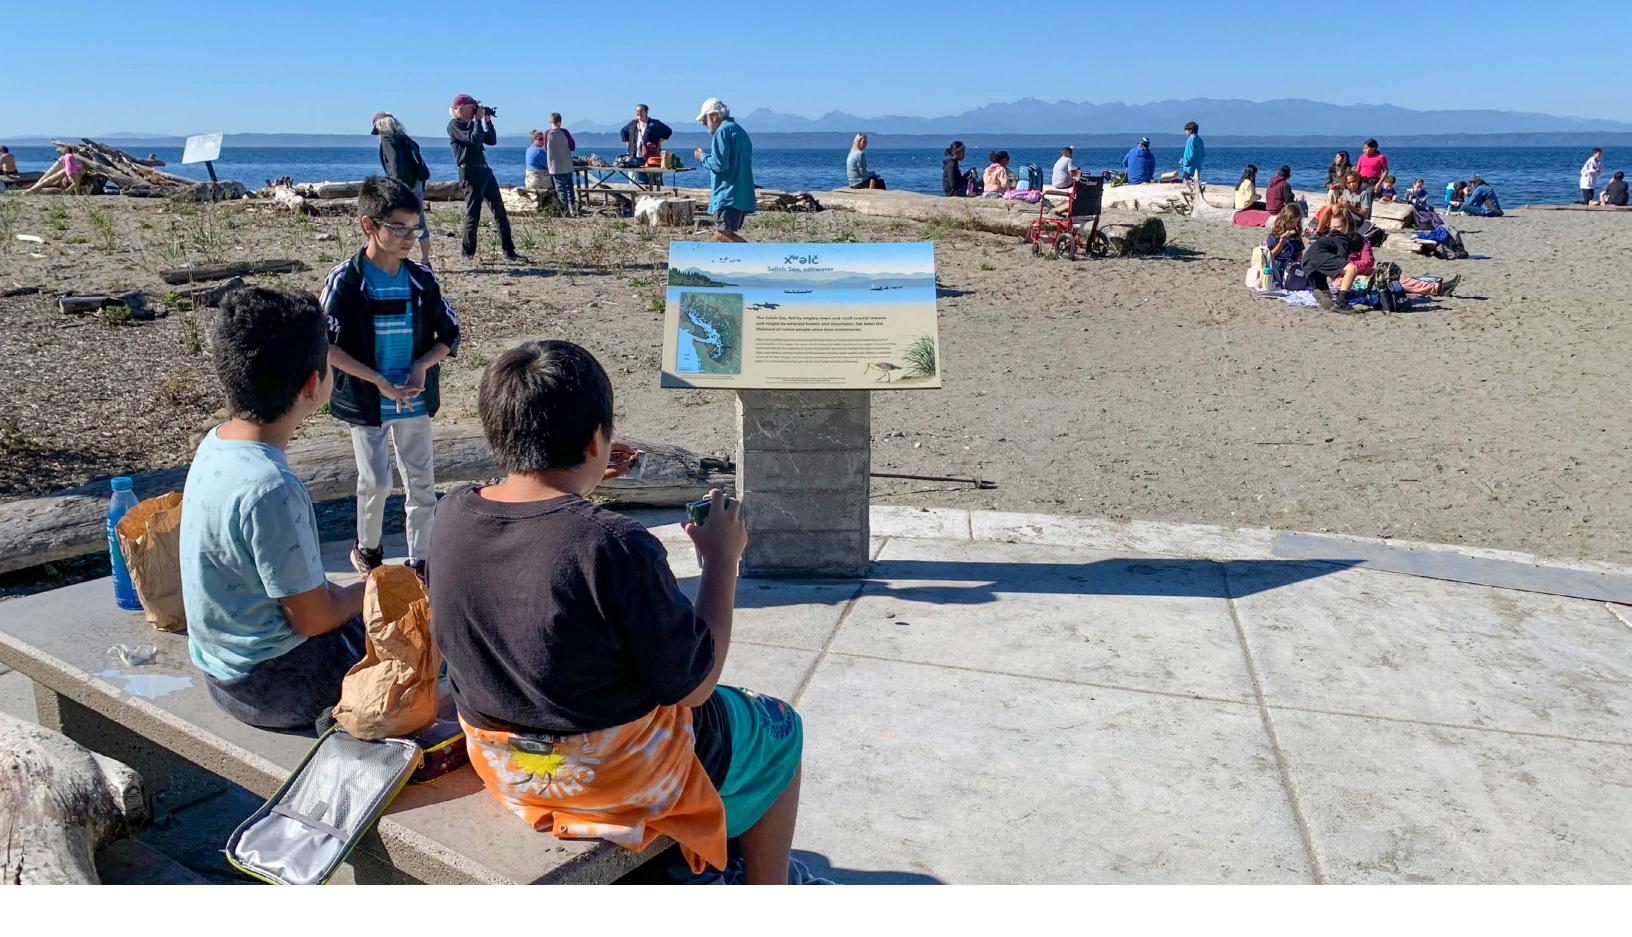
The accessible pathway terminates in a curved beach front concrete plaza. The plaza provides a place to rest and view the water from solid ground. An interpretative sign provides historical context and an invitation to take care of the Salish Sea.

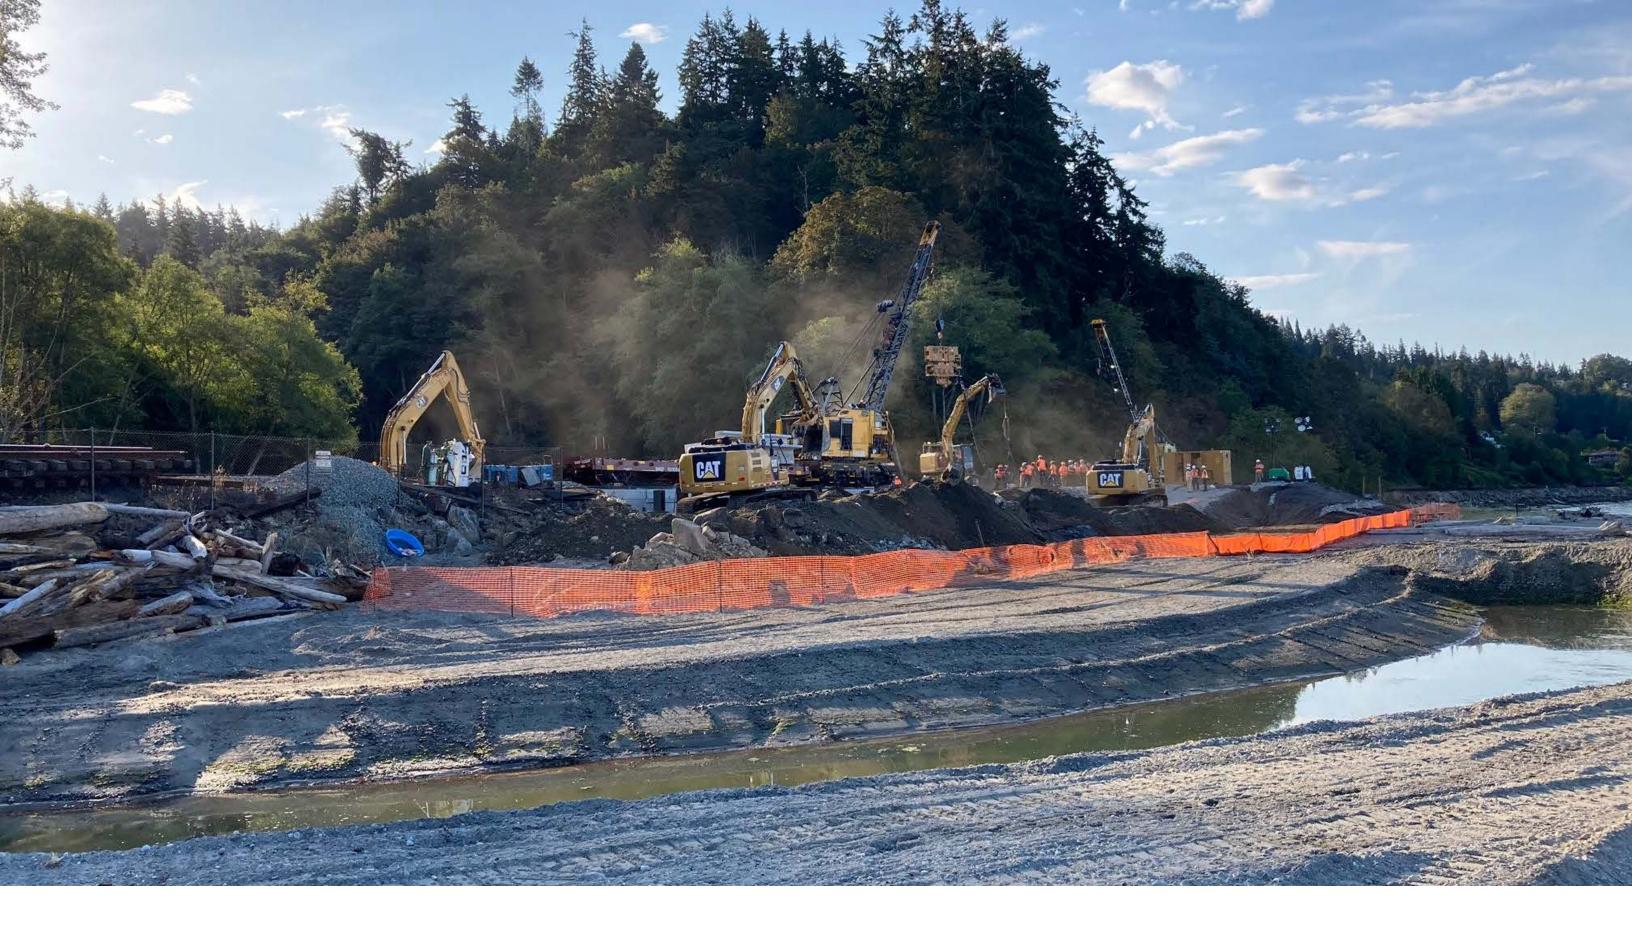
Construction of the five-span railroad bridge was accomplished under live train traffic, with up to 50 trains per day traveling on two side-by-side tracks. During bridge installation, a coordinated team of more than 50 workers replaced the mainline tracks in a 24-hour work window with only intermittent closures of up to 2 hours.

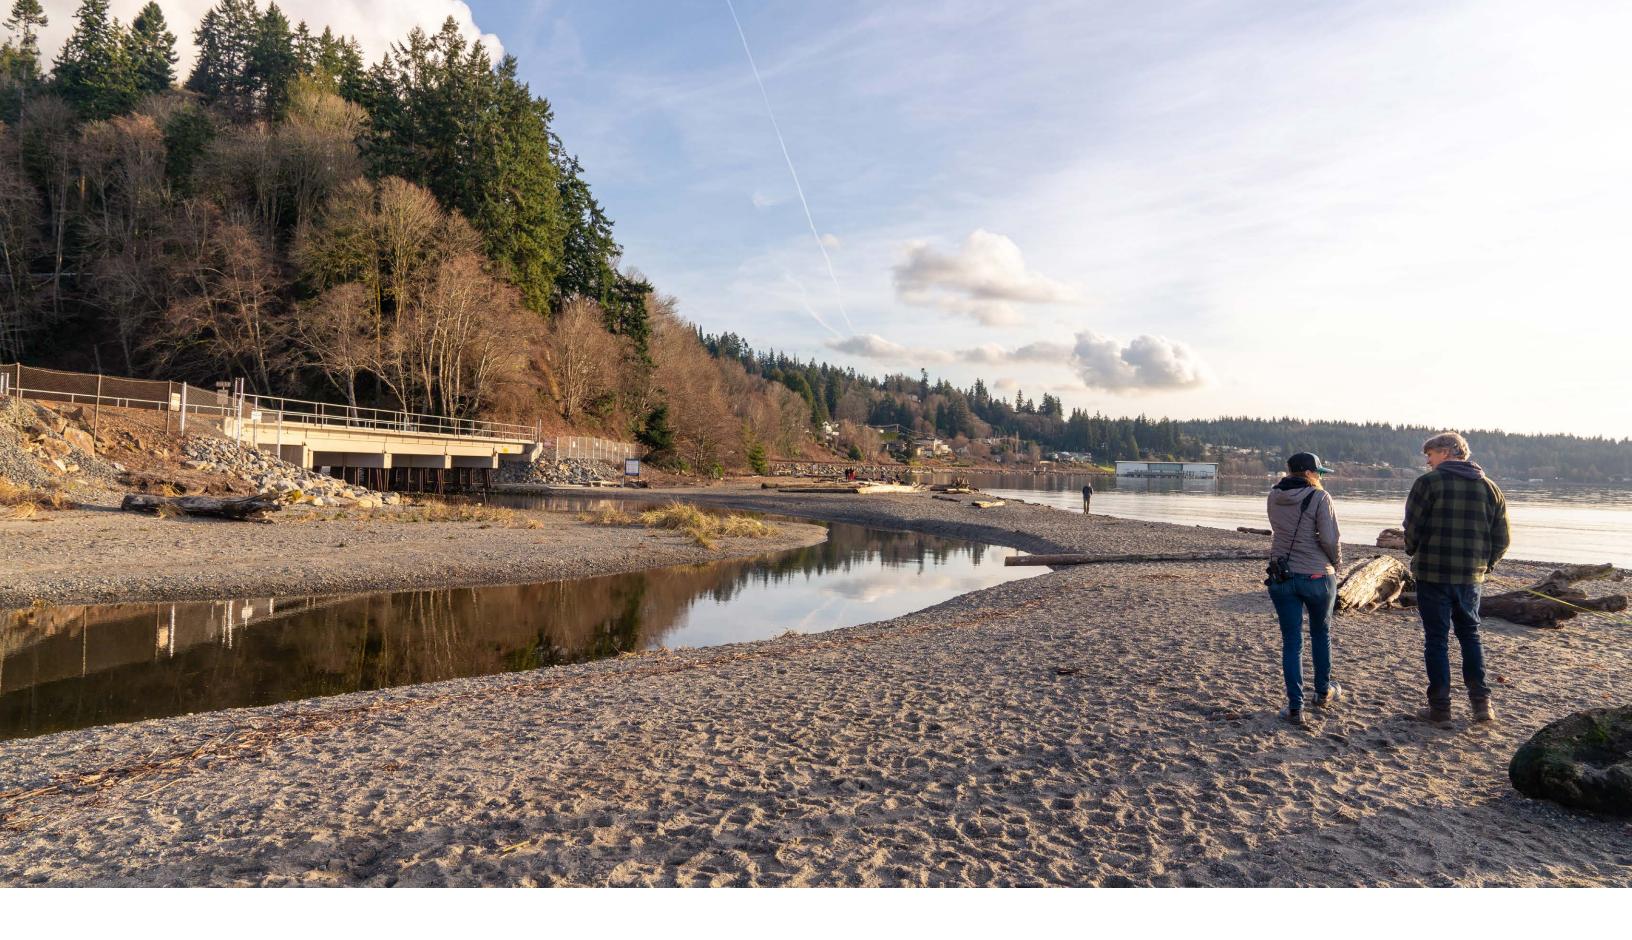
The channel flows along its historical alignment. Visitors can now safely access this sandy beach year-round, and migrating and juvenile fish have a generous passage to support their life cycles.
