ZHENJIANG SPONGE CITY RETROFIT AREA MAP

01 Jianger Neighborhood Sponge City Retrofit Project Location Map

Zhenjiang city is one of 16 pilot Sponge Cities in Southeast of China. The 29 km² pilot area has 40 old neighborhoods that need renovation.

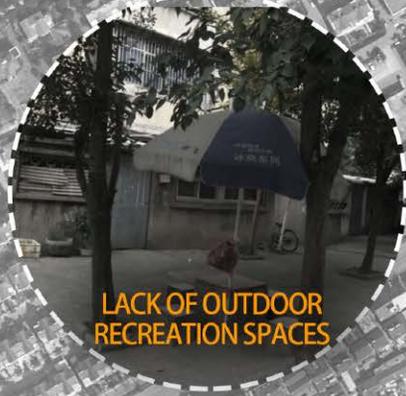
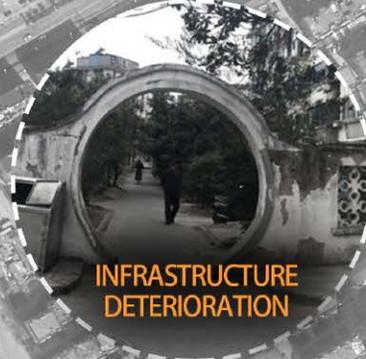
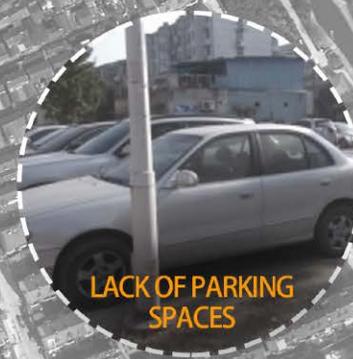
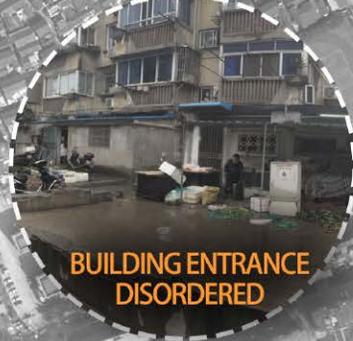
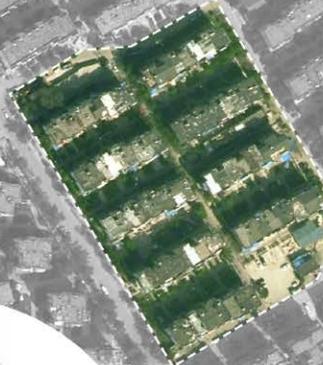
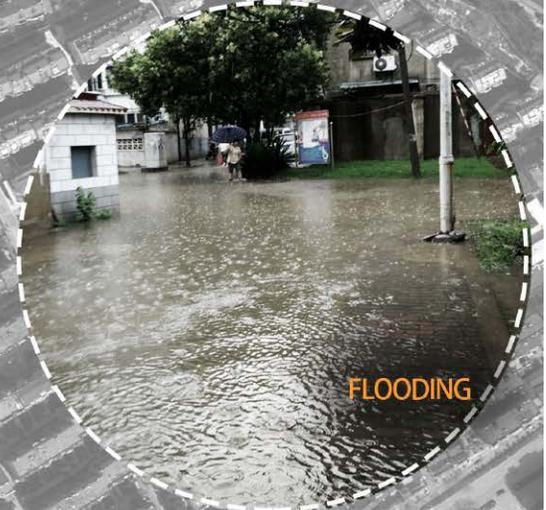
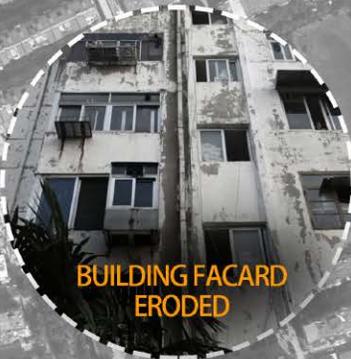
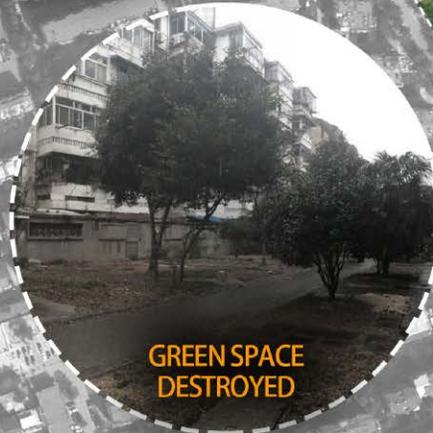
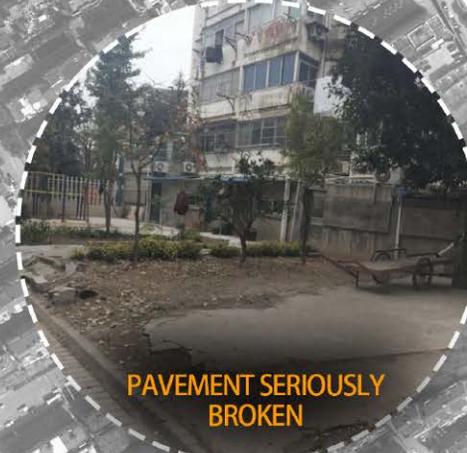
02 Common Problems

GREEN SPACE DESTROYED

These 40 neighborhoods endured common problems such as annual flooding, sewer surcharge, deterioration of aging infrastructures, lack of parking space, destroyed green space and broken pavement for years.

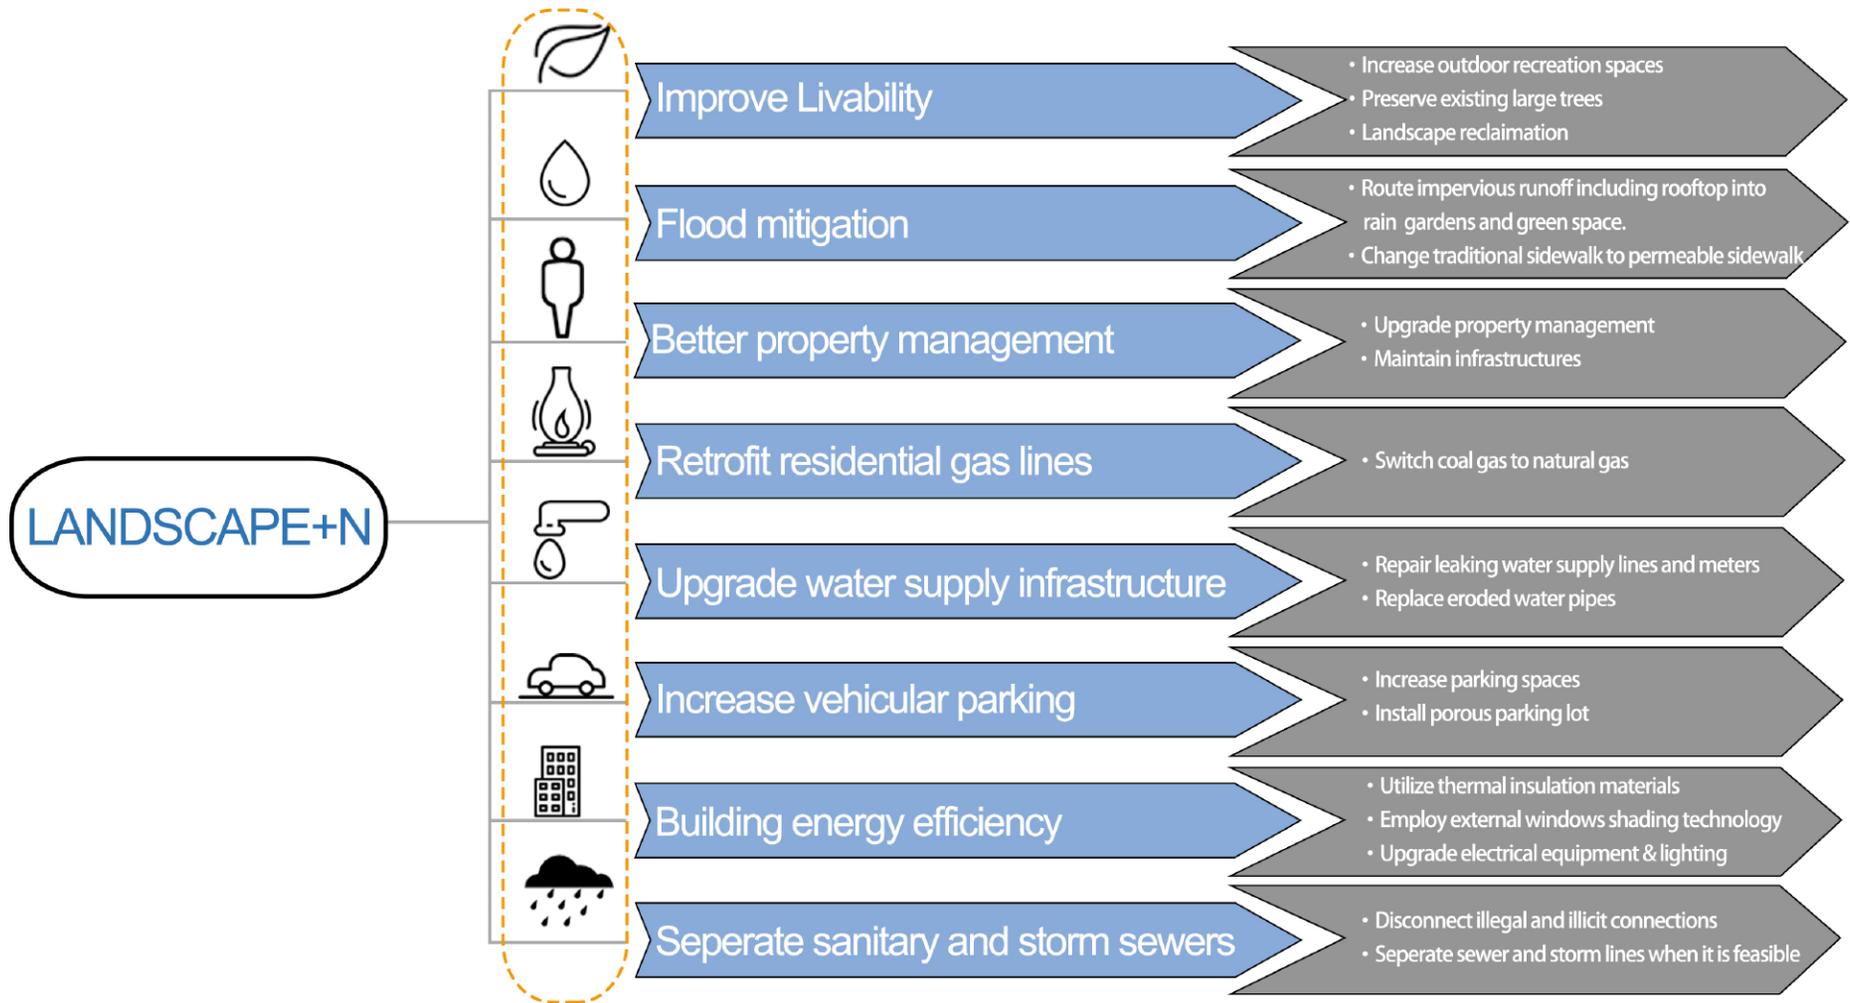
03 Innovative Solutions

“Landscape + N” solution which include green stormwater infrastructure (GSI), energy conservation, utilities upgrades, installation of parking lot, preservation of productive landscape and better management for mitigating flood and other problems of the neighborhood is implemented.

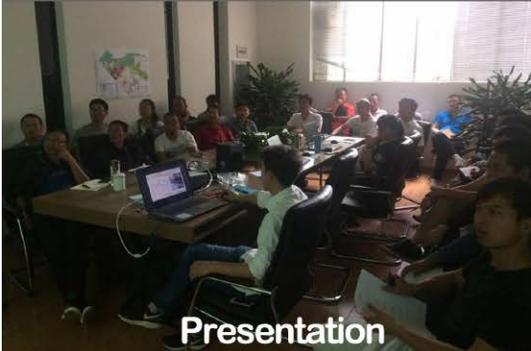
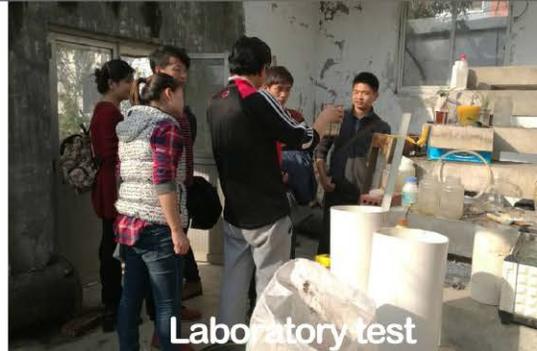
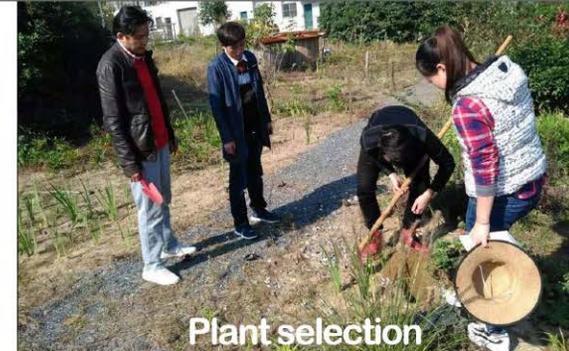
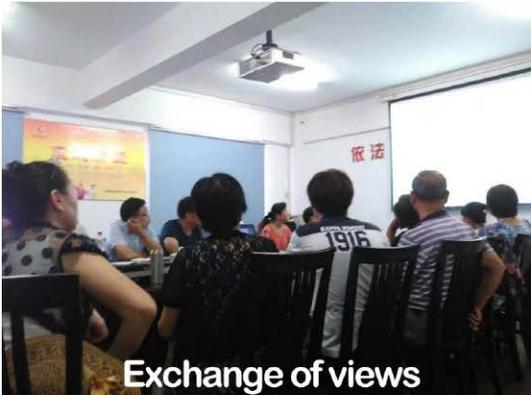
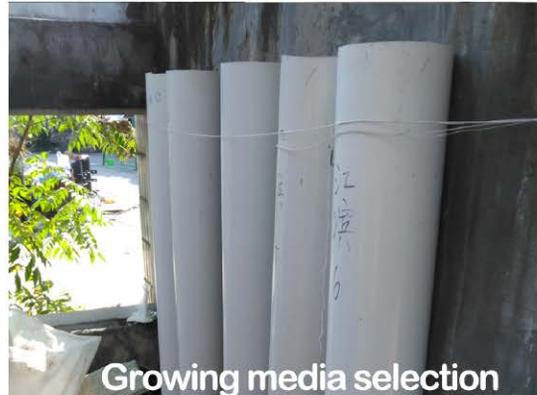
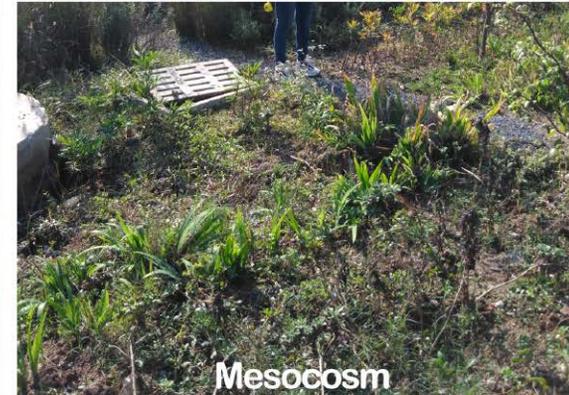
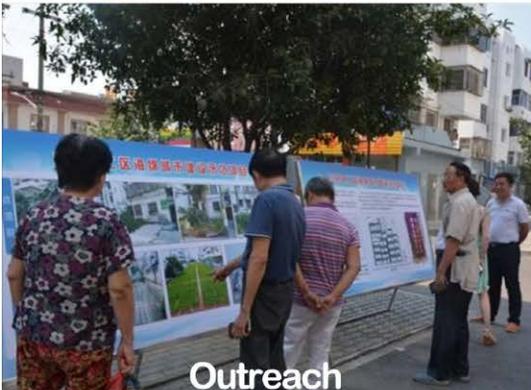
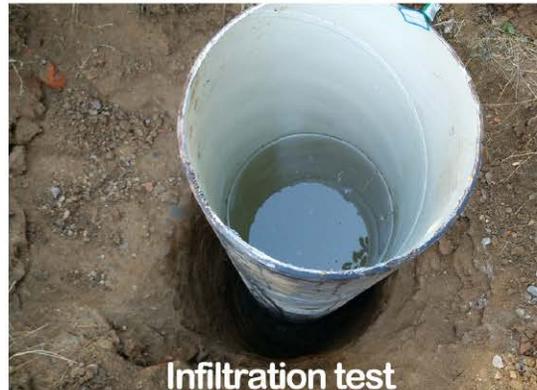
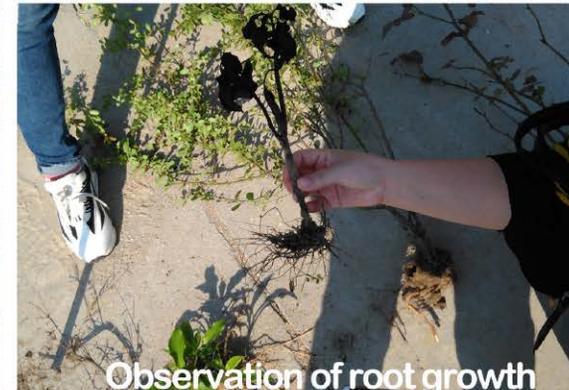
04 Collaboration and Research

Soil property test

Plant adaptability test

Stakeholder worked together in the entire design process. Numerous growing media and plants were tested and selected to ensure runoff volume reduction and pollution removal as well as satisfying residents' aesthetic perception.

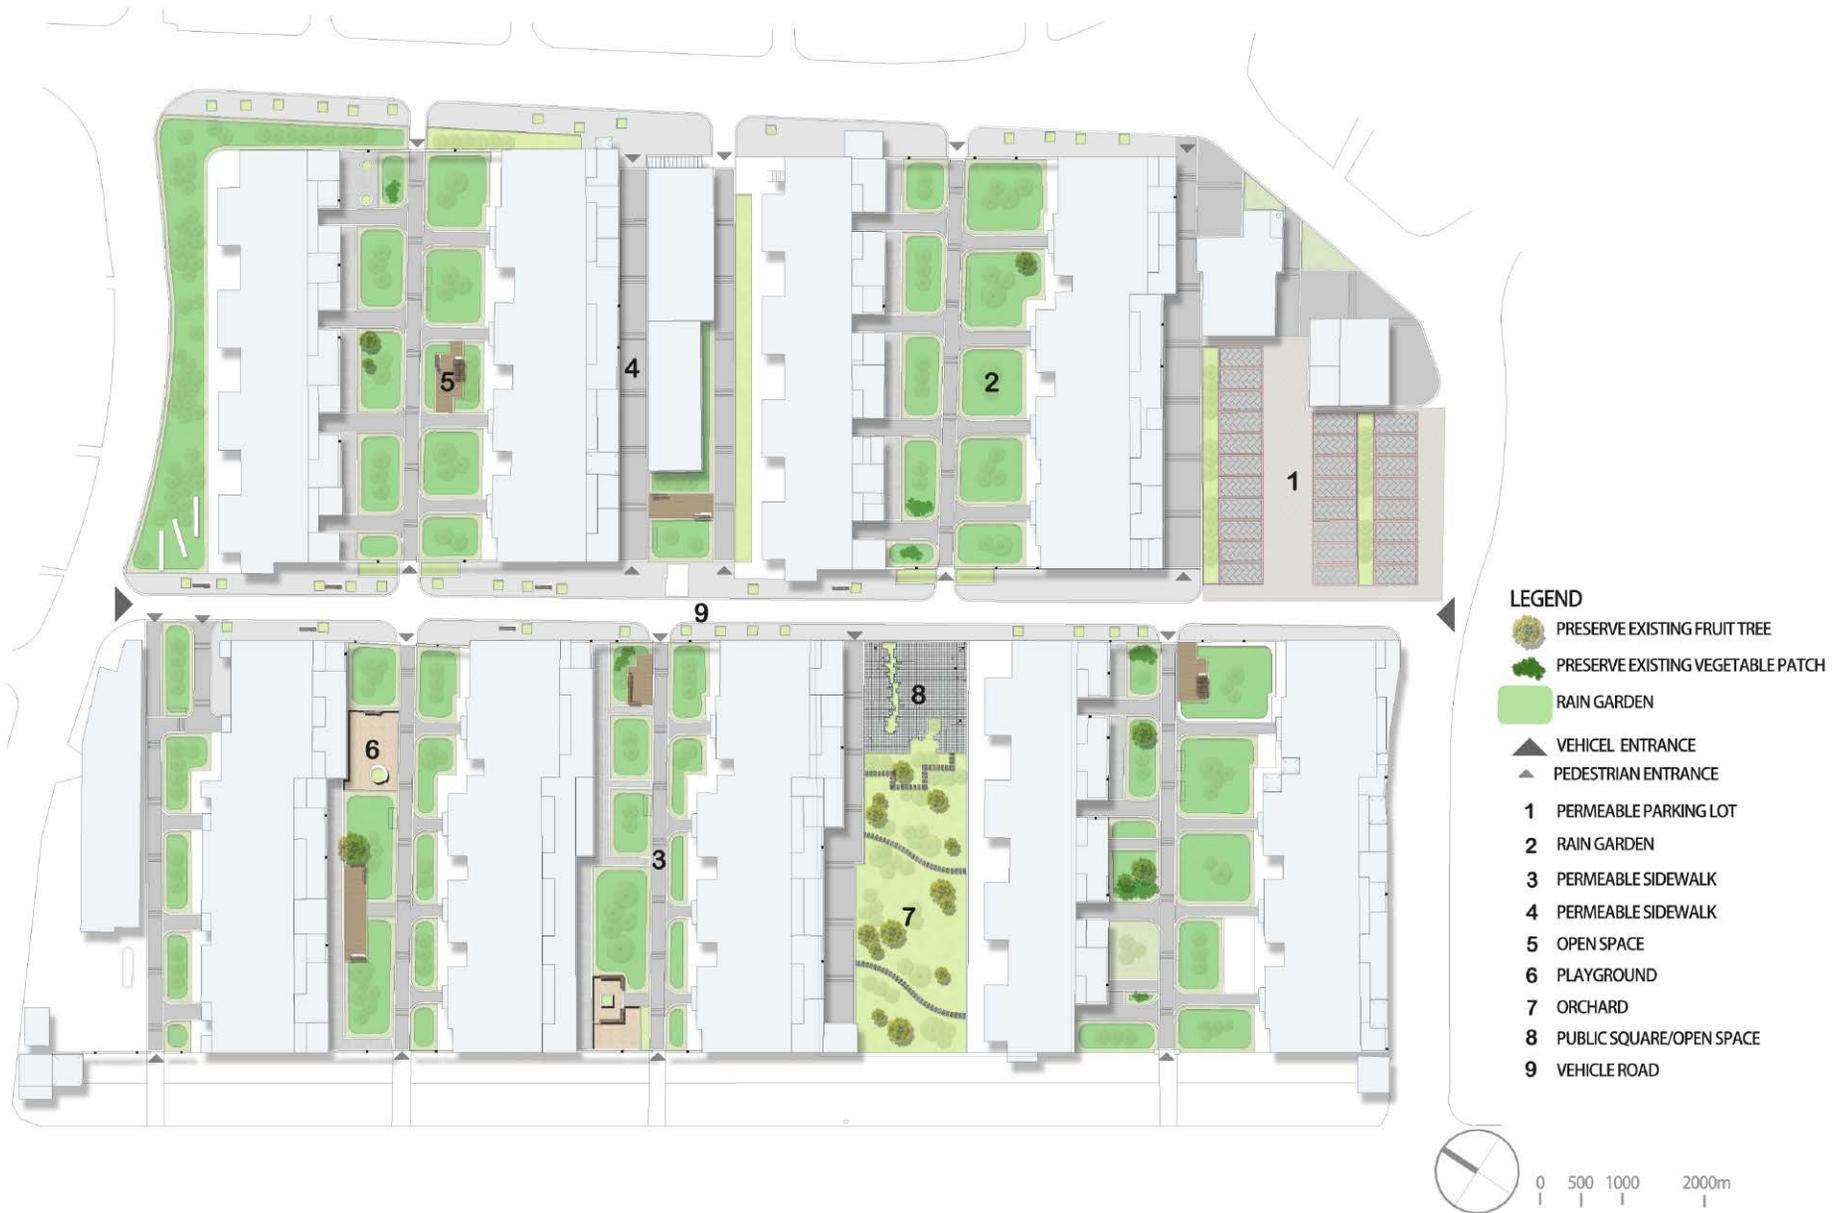
SITE PLAN

05 Analysis
Resilient landscape was proposed to stakeholders.

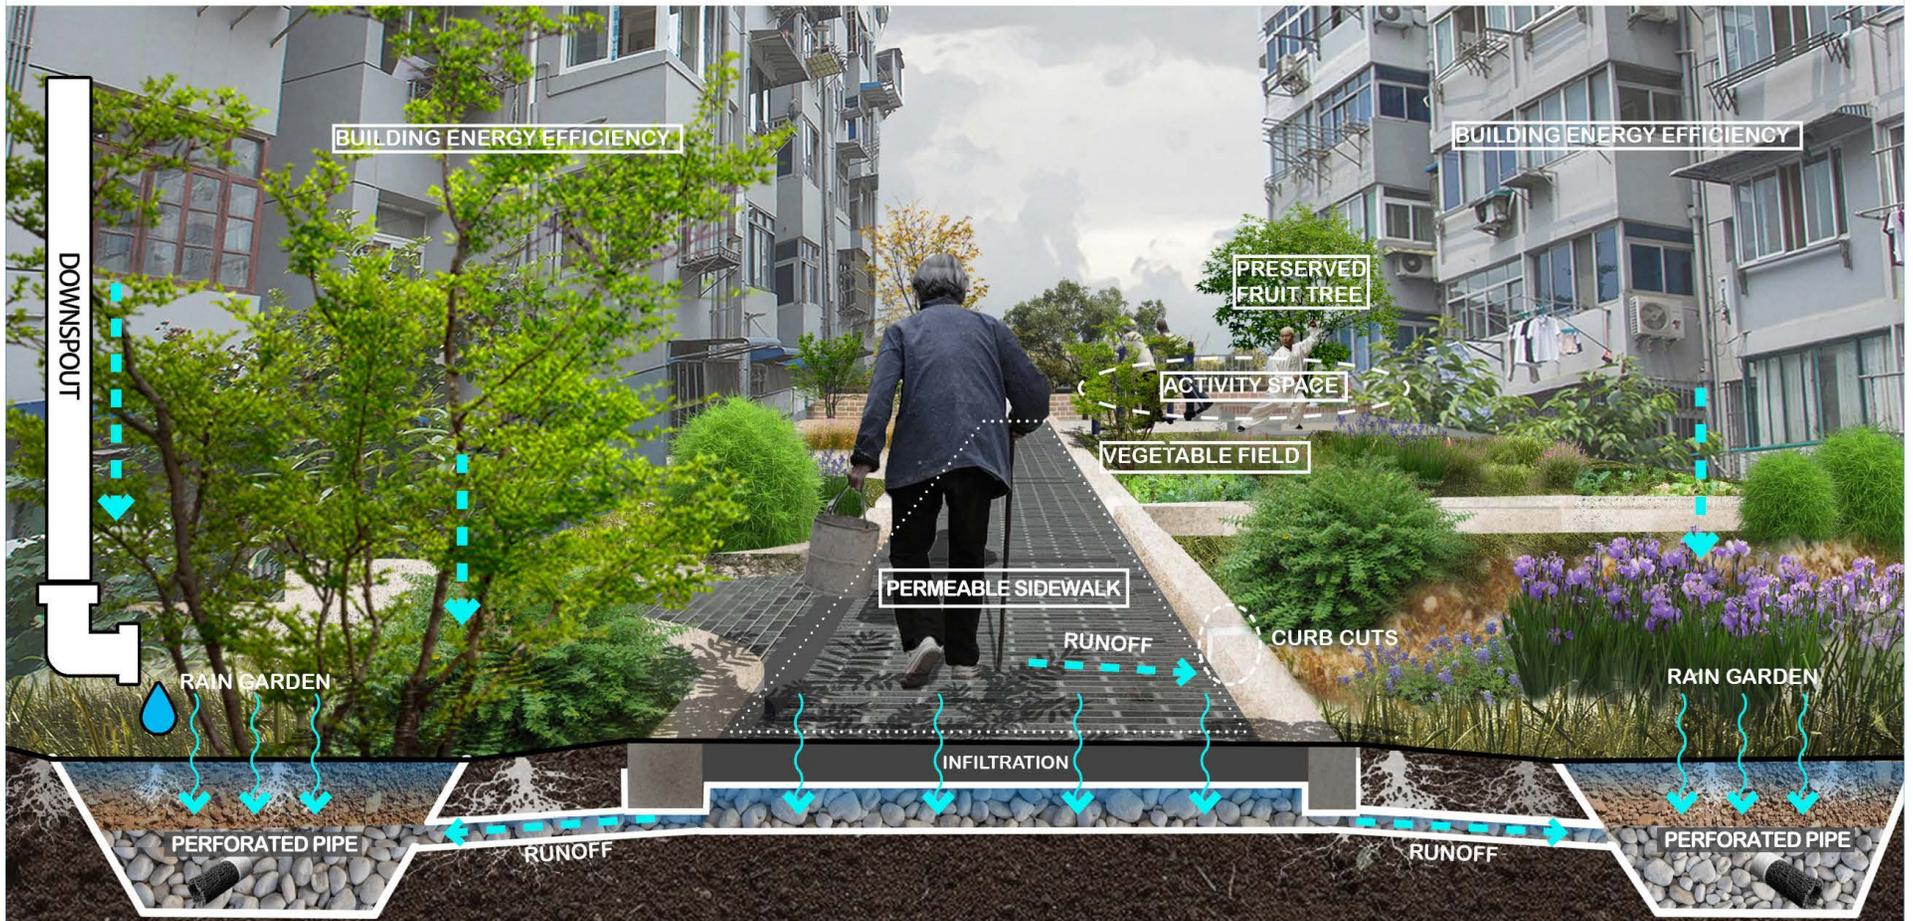
CONCEPTUAL DESIGN

06 Design
Conceptual design showed how resilient landscape works.

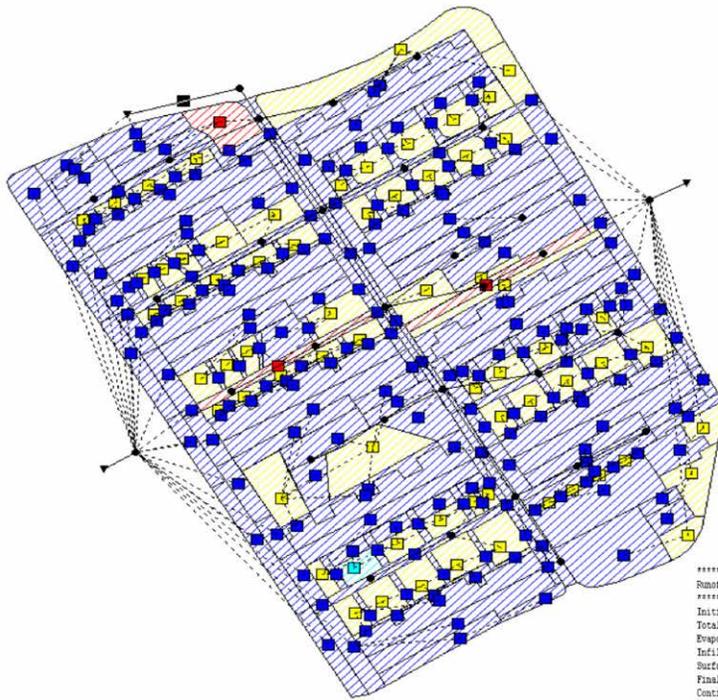
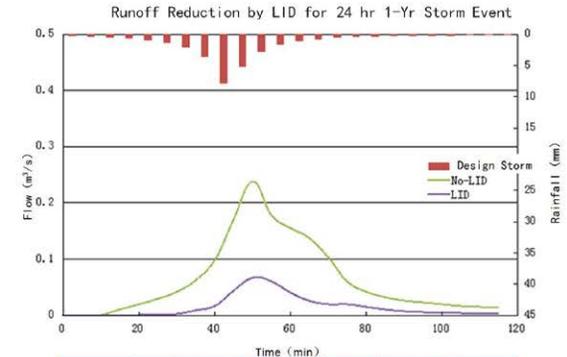
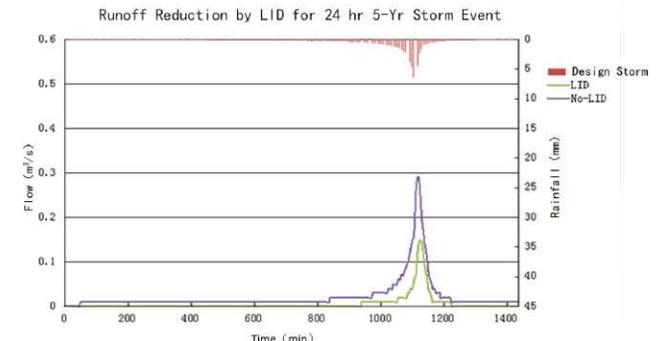
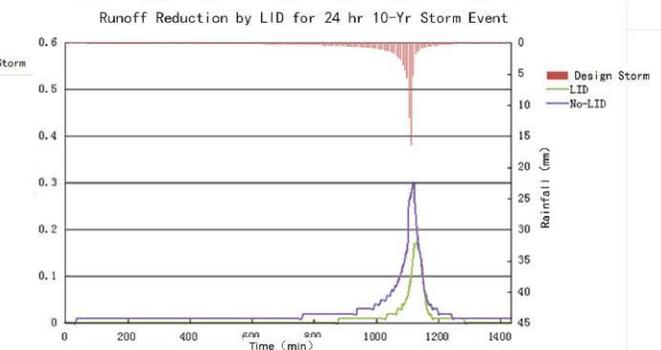
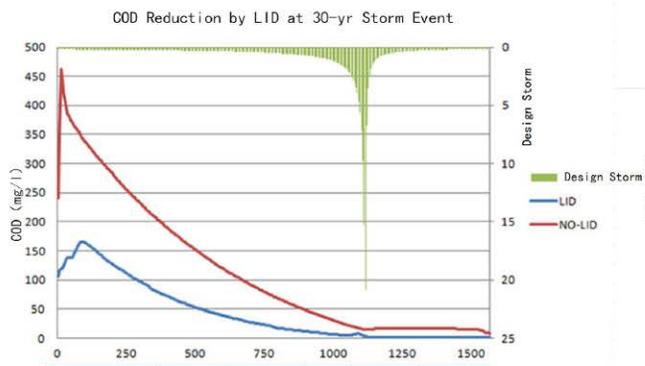
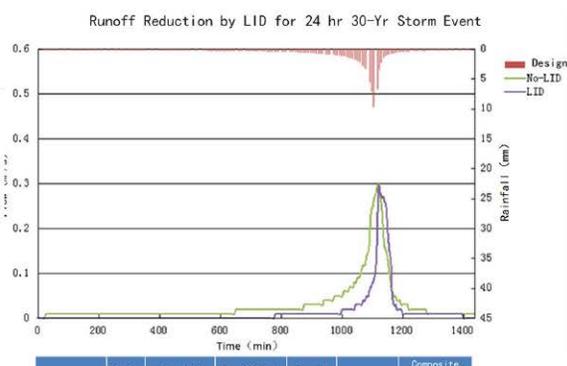
USING SWMM TO BUILD THE HYDROLOGIC MODEL

1-yr	Rainfall (mm)	Rainfall Peak Time (min)	Runoff Peak Time (min)	Runoff Volume (m³)	Peak Flow (m³/s)	Composite Runoff Coefficient
Before	34.5	40	50	550	0.24	0.85
After	34.5	40	50	180	0.07	0.28

5-Yr	Rainfall (mm)	Rainfall Peak Time (min)	Runoff Peak Time (min)	Runoff Volume (m³)	Peak Flow (m³/s)	Composite Runoff Coefficient
Before	146.6	1115	1120	2330	0.29	0.85
After	146.6	1115	1125	970	0.15	0.35

10-Yr	Rainfall (mm)	Rainfall Peak Time (min)	Runoff Peak Time (min)	Runoff Volume (m³)	Peak Flow (m³/s)	Composite Runoff Coefficient
Before	175	1115	1120	2810	0.3	0.85
After	175	1115	1125	1290	0.17	0.4

30-Yr	Rainfall (mm)	Rainfall Peak Time (min)	Runoff Peak Time (min)	COD Load (kg)	COD Concentration (mg/l)	Composite Runoff Coefficient
Before	220	1115	1120	179.66	461.47	0.87
After	220	1115	1125	20.3	165.79	0.46

30-Yr	Rainfall (mm)	Rainfall Peak Time (min)	Runoff Peak Time (min)	Runoff Volume (m³)	Peak Flow (m³/s)	Composite Runoff Coefficient
Before	220	1115	1120	3600	0.3	0.87
After	220	1115	1125	1890	0.29	0.46

Using SWMM model to simulate proposed resilient landscape design for various return period of storms.

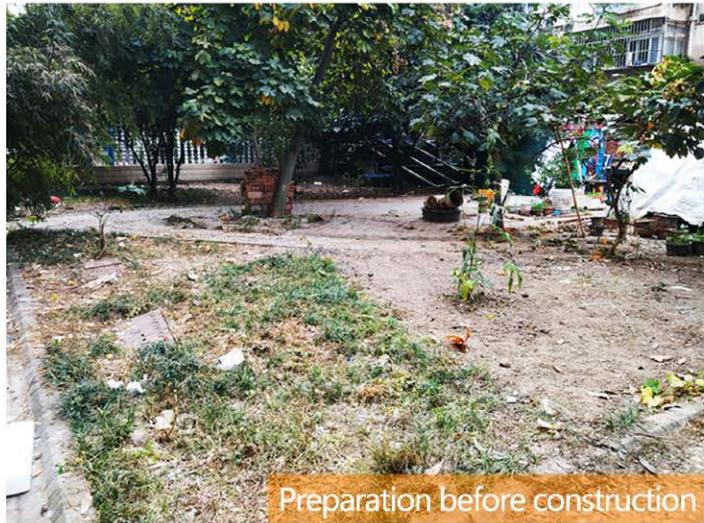
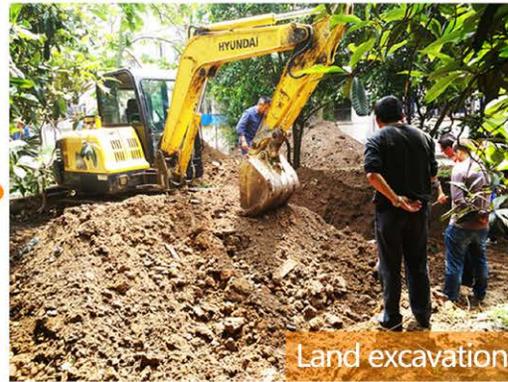
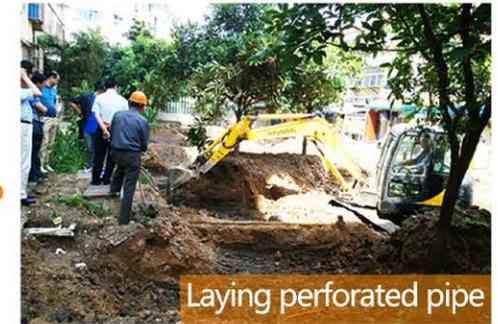
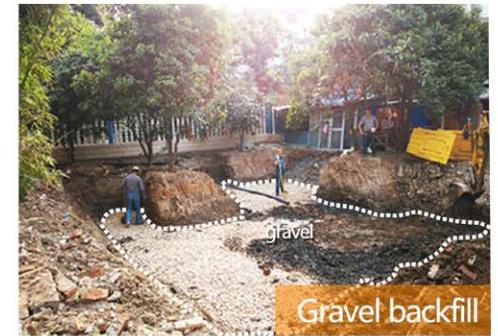
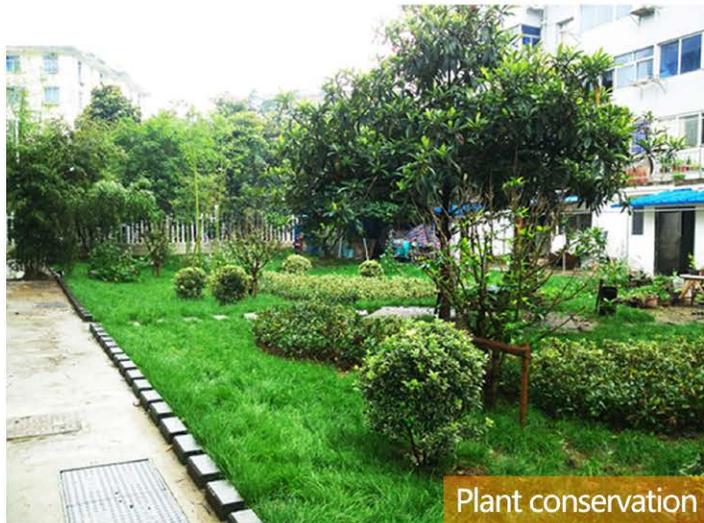
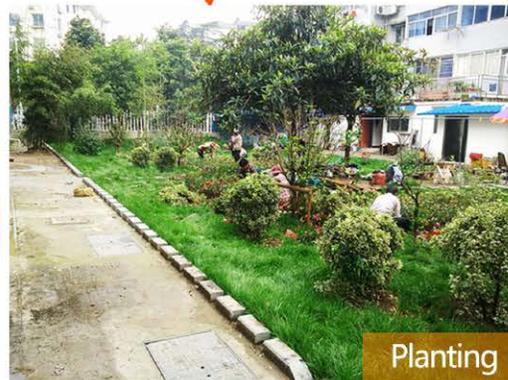
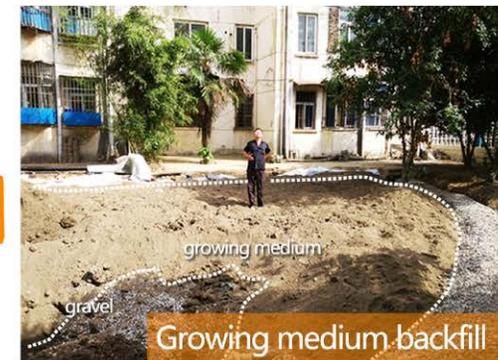
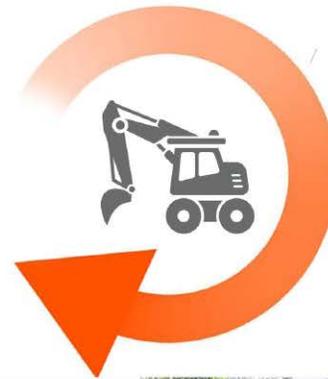
08 Construction Process

Designers were involved in the entire construction process from pre-construction training to construction observation to site problem solving.

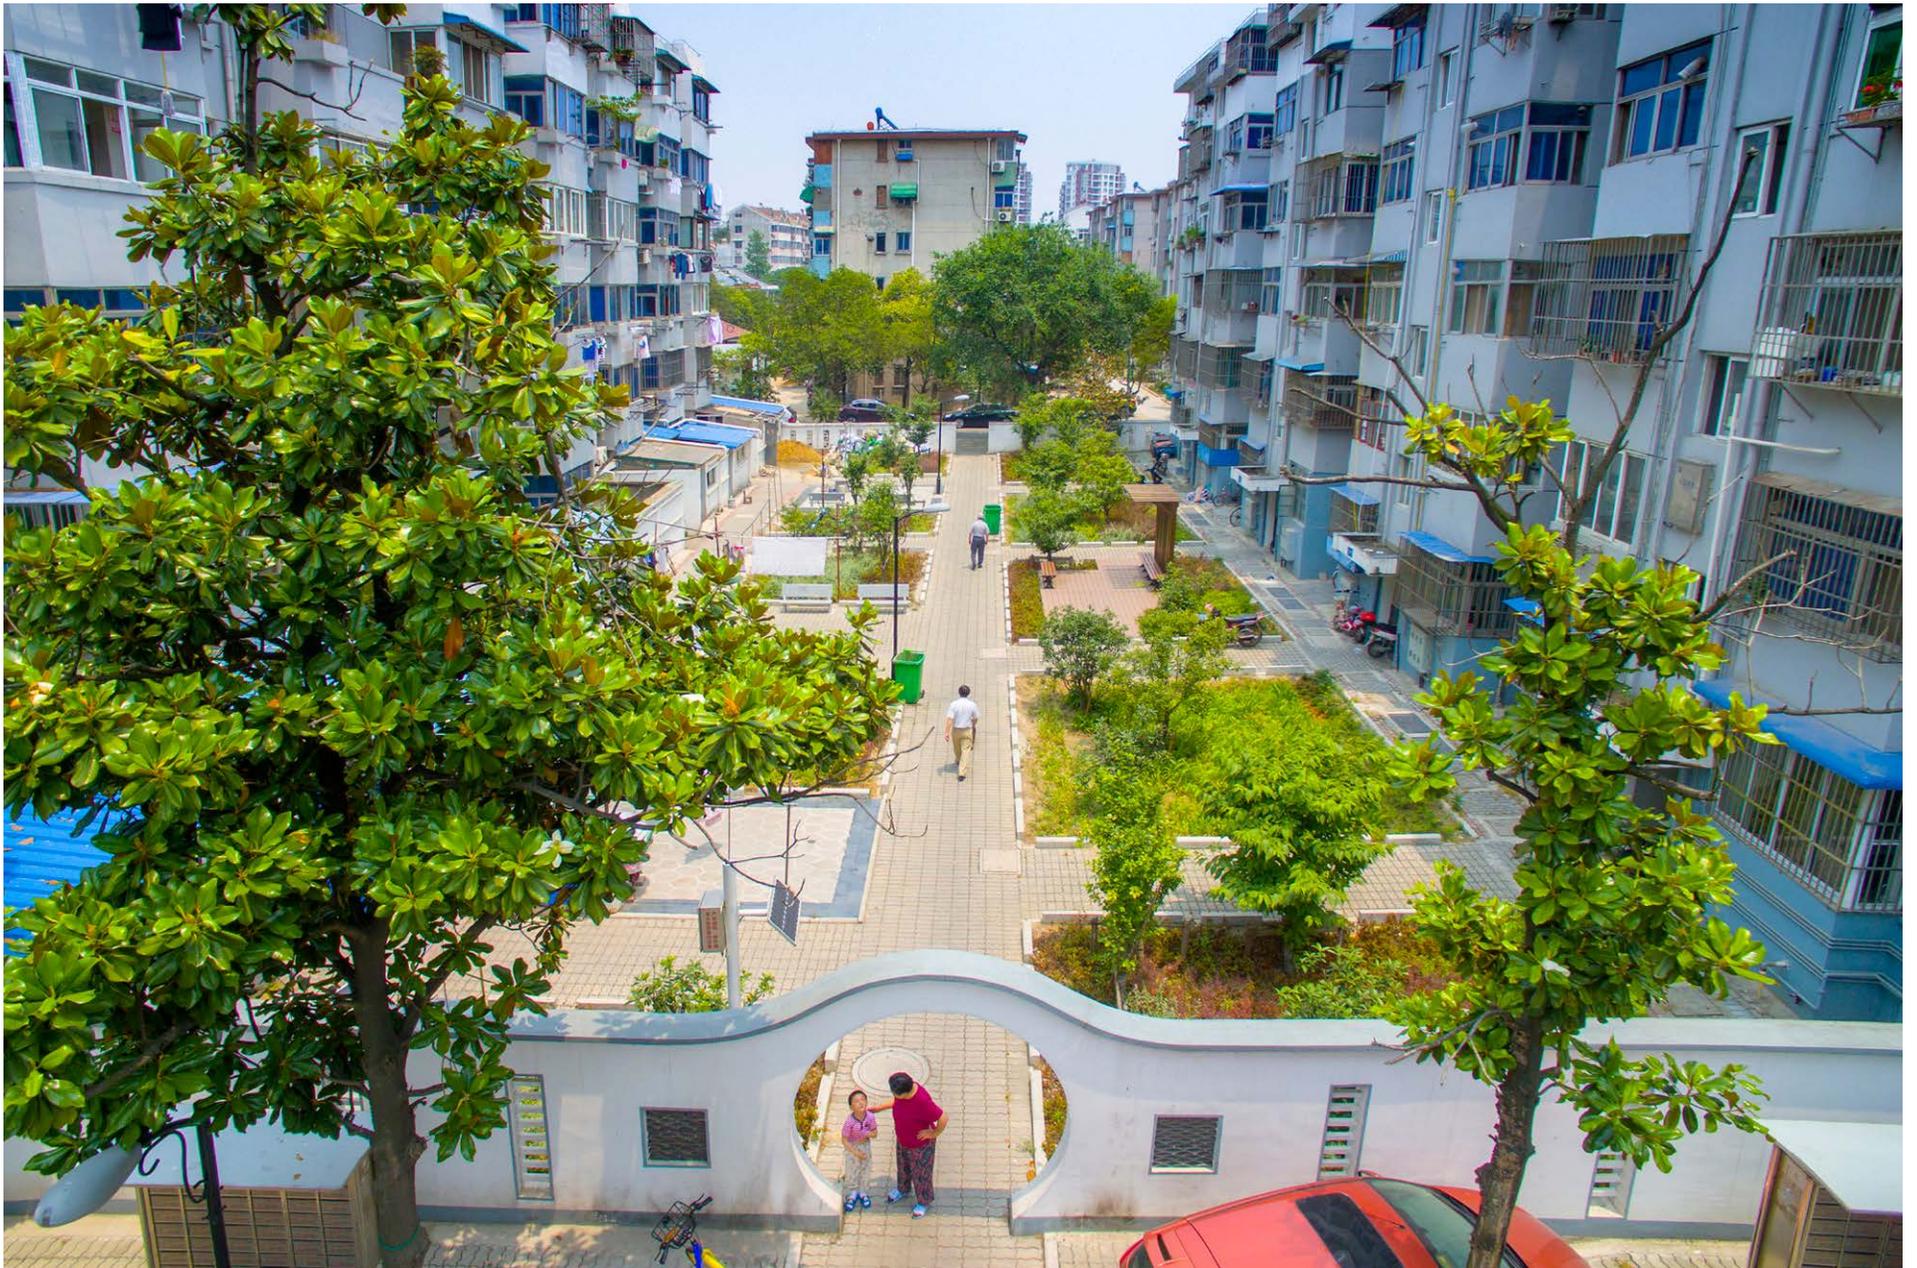
09 Project Construction Completion

“Landscape + N” solution helped to lower the construction cost compared to traditional solutions by at least 30%. It also lowers the operational and maintenance cost significantly for future.

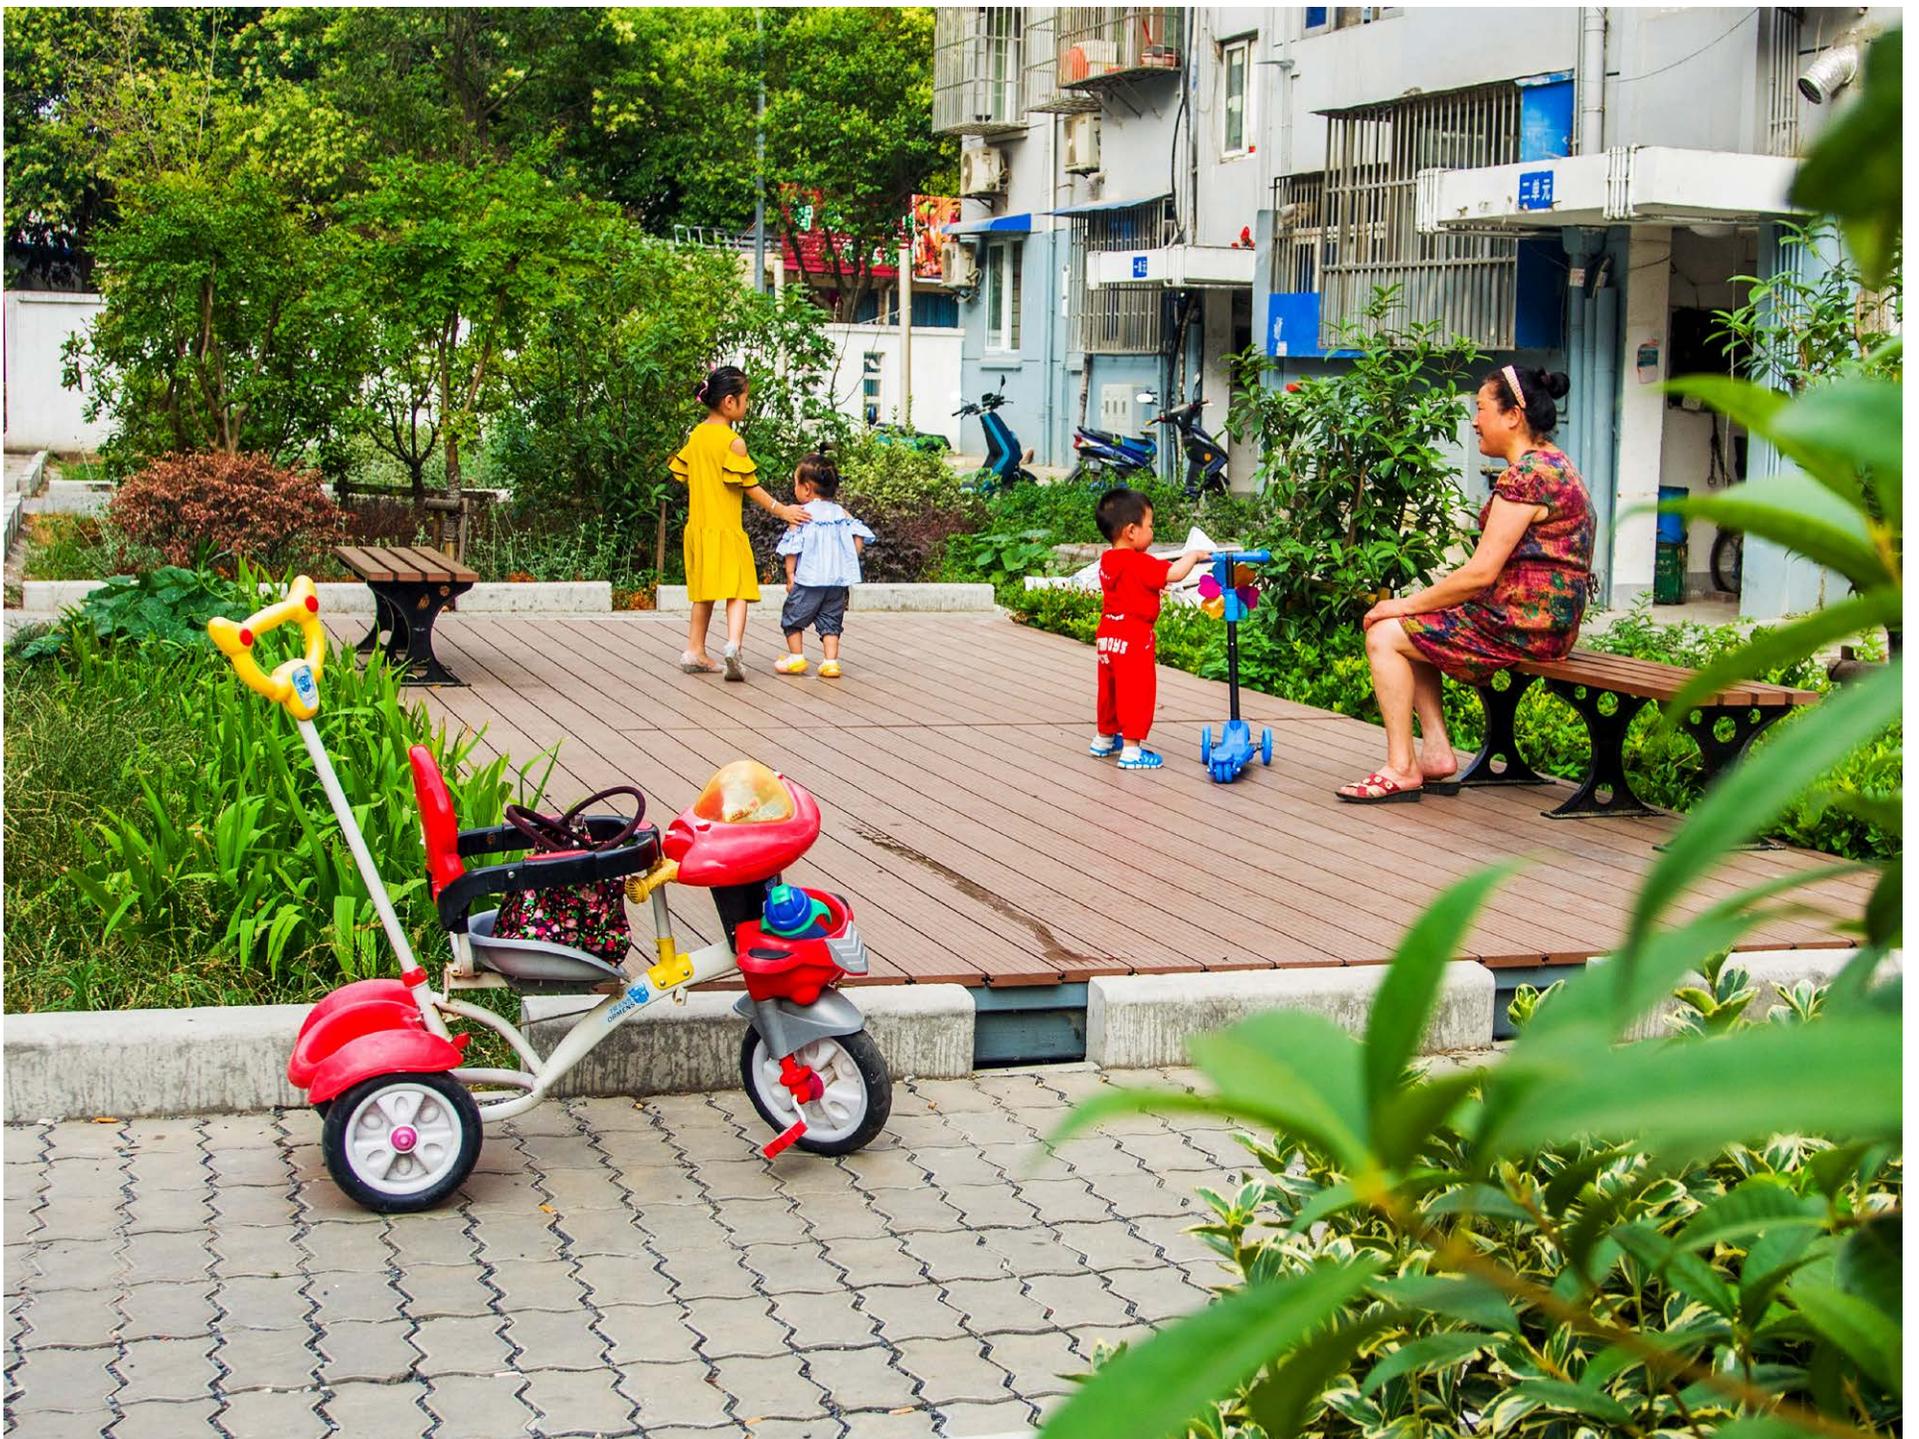
10 Mini Playground

Mini playground as well as the resilient landscape created by the designers provide an enjoyable naturalistic oasis for both children and elderly to improve their quality of life.

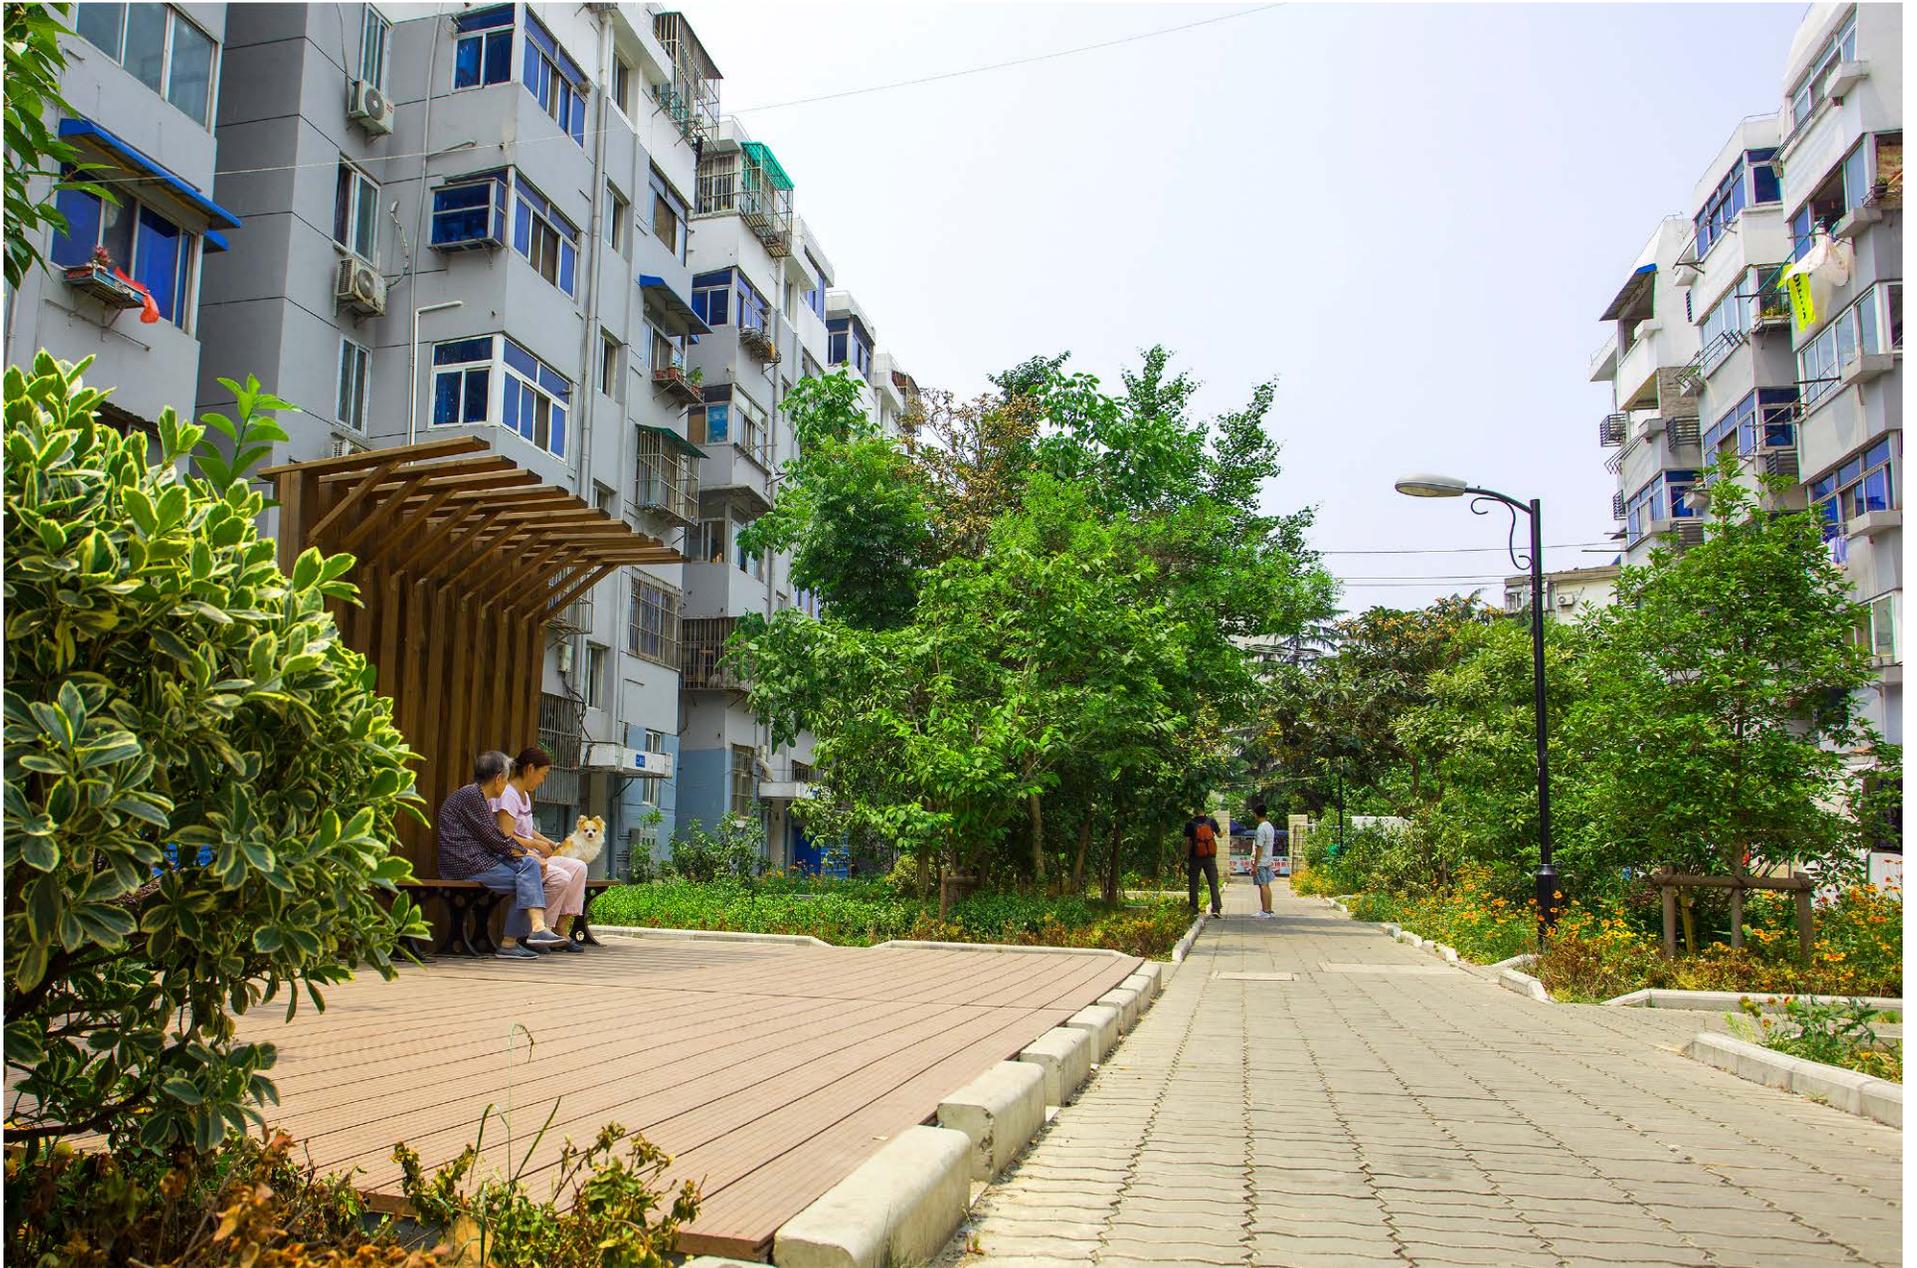
11 Environmental and Social Benefits

One of the many environmental and social benefits generated by resilient landscape design is that mosquitoes are reduced dramatically in the neighborhood. As the result people are more likely to go outside for various social activities.
