ZHENJIANG SPONGE CITY RETROFIT AREA MAP

01 Jianger Neighborhood Sponge City Retrofit Project Location Map

Zhenjiang city is one of 16 pilot Sponge Cities in Southeast of China. The 29 km² pilot area has 40 old neighborhoods that need renovation.

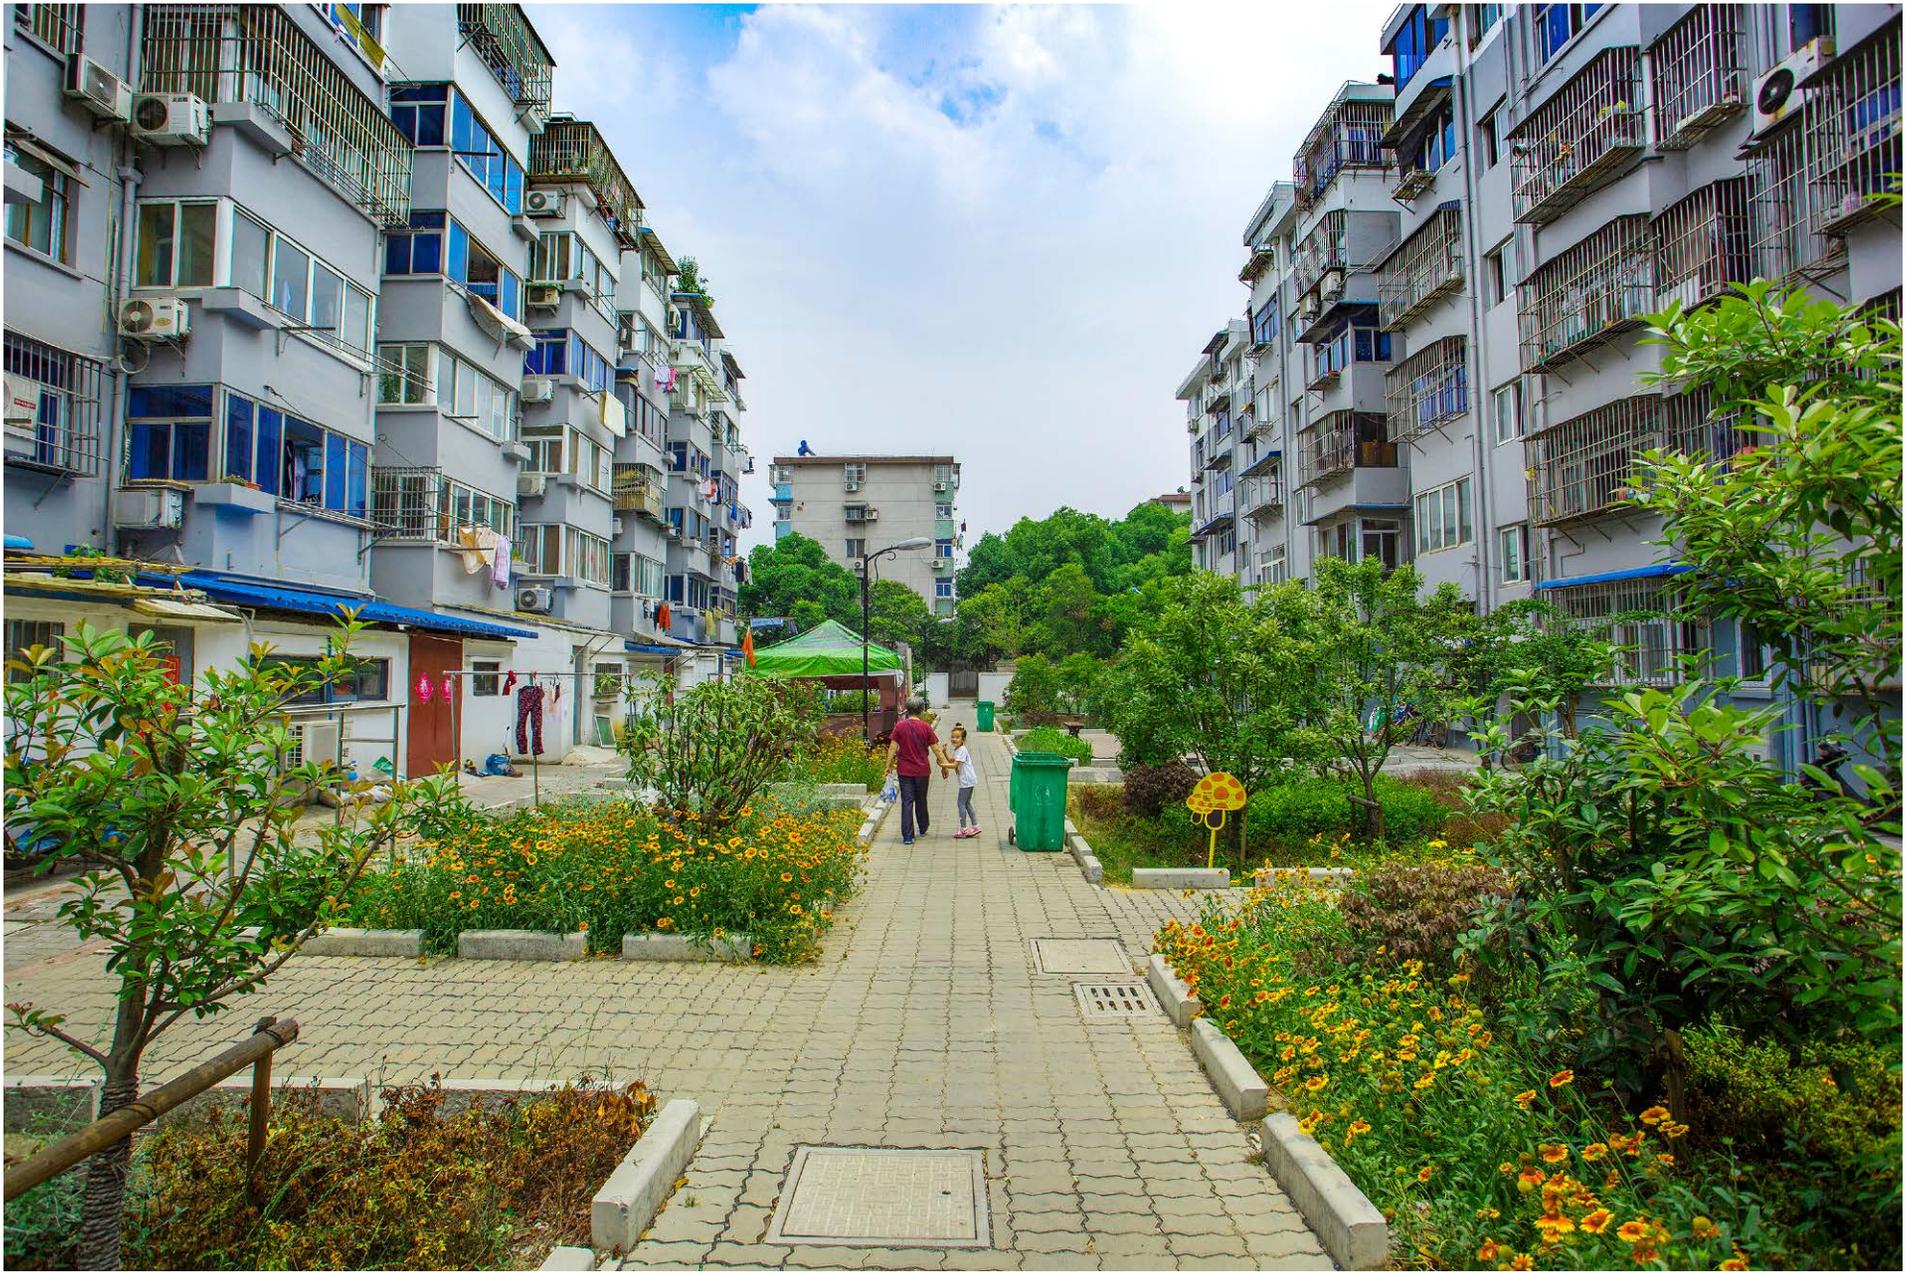
12 Aesthetics

Resilient landscape changed people's general stereotypes that GSI does not look pretty.

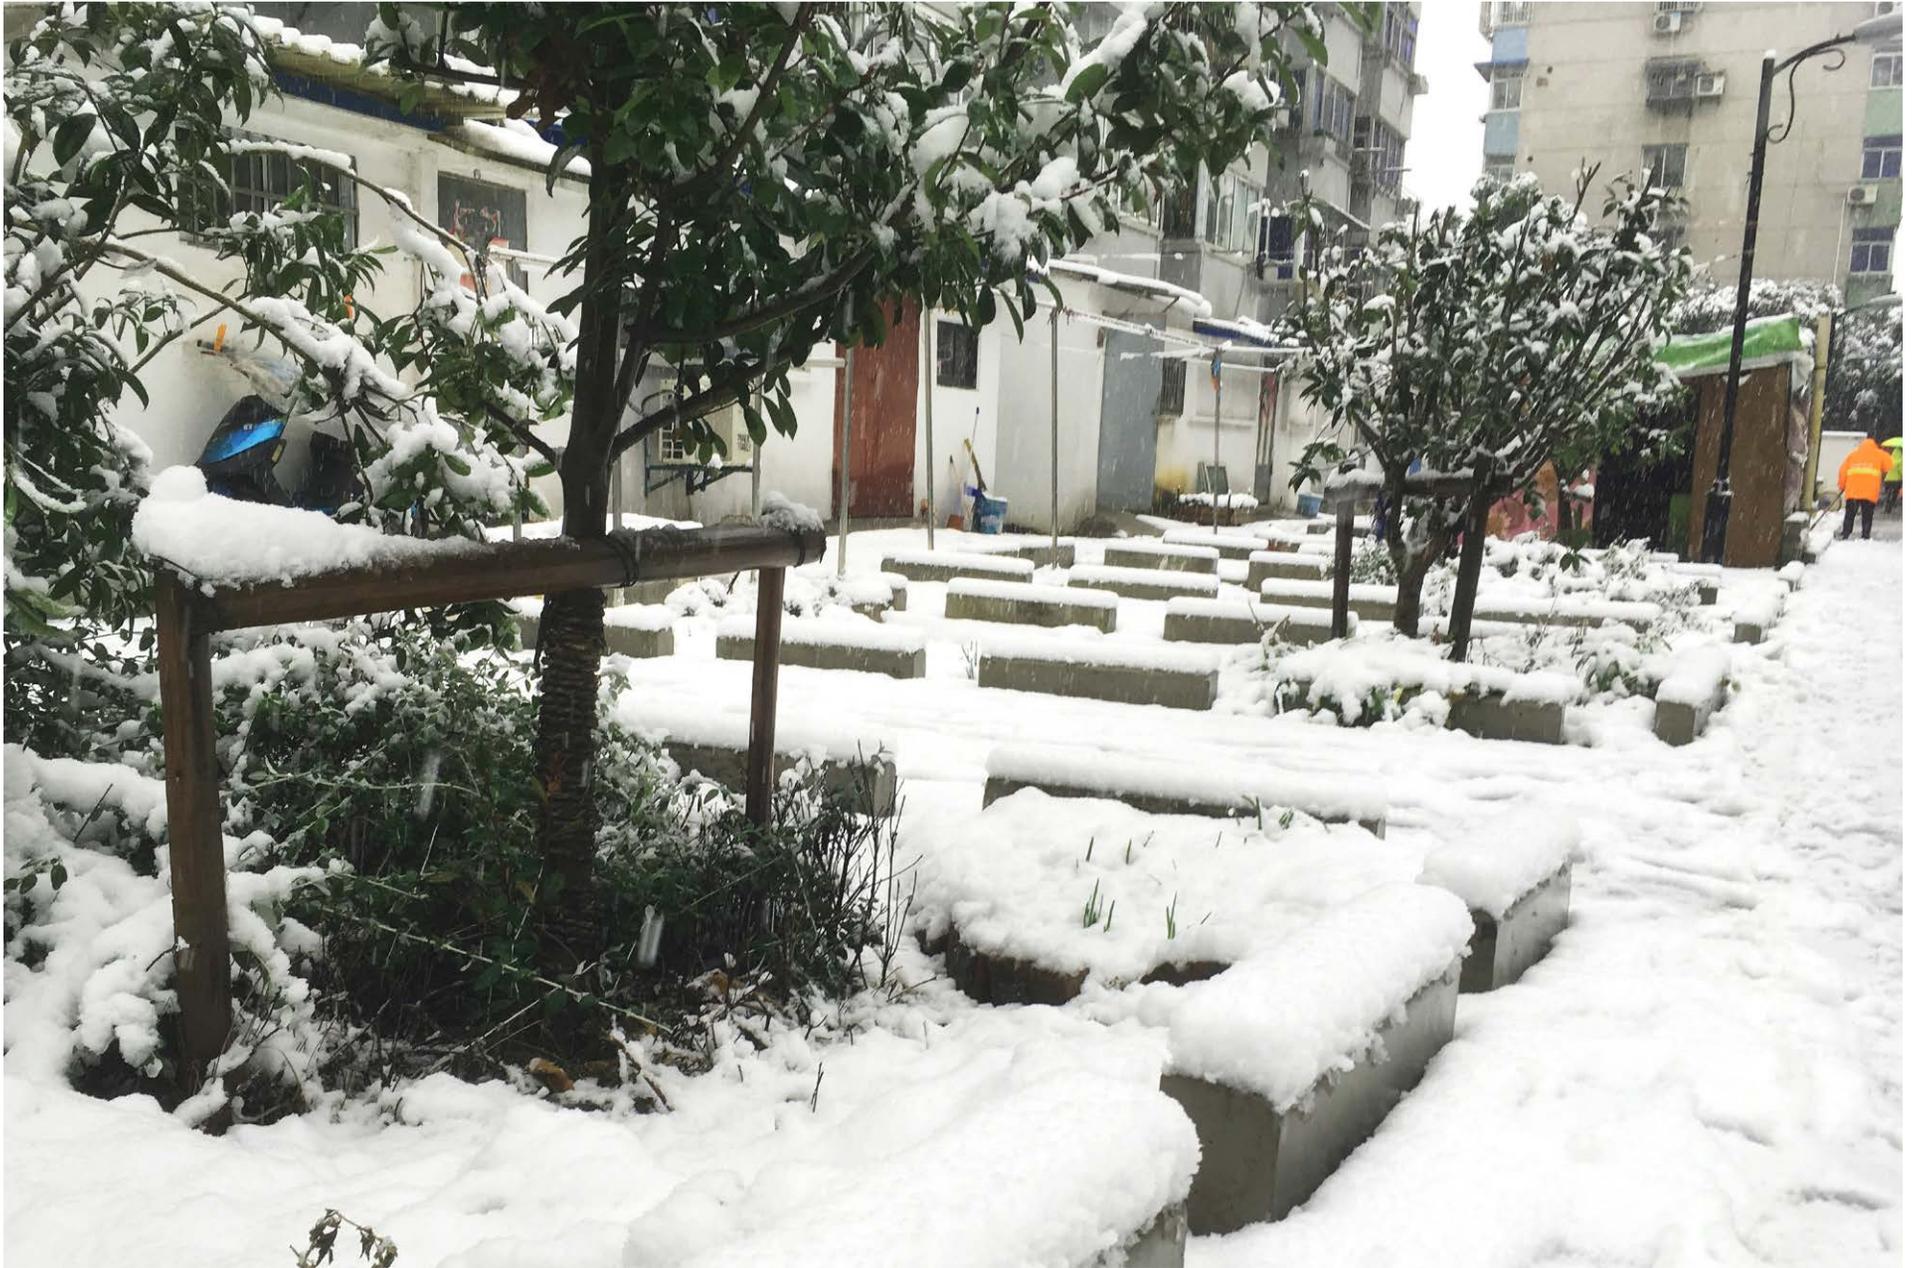
13 Climate Resilient

Plants selected for GSI are not only tolerate for humid and dry warm weather, but also for cold weather.

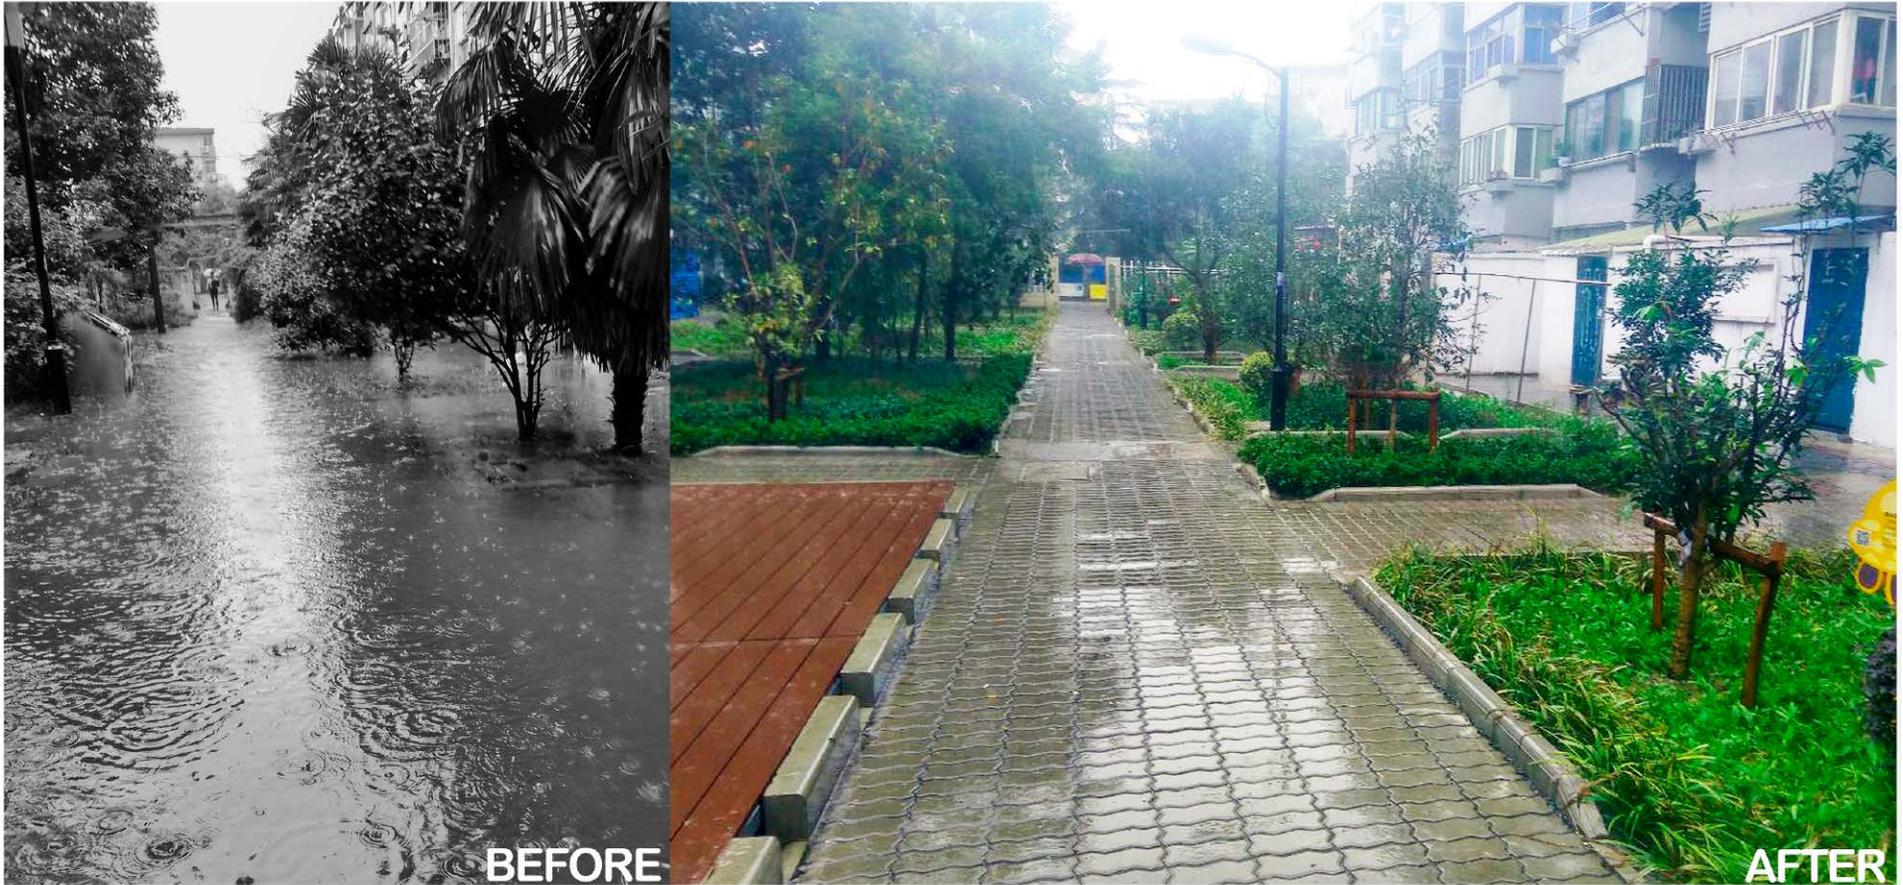
14 Resilient for Extreme Weather Conditions

After the construction completion in 2015 the neighborhood was hit twice by large storms. One storm was 138 mm, another was 125 mm. But no standing water was found in the neighborhood.

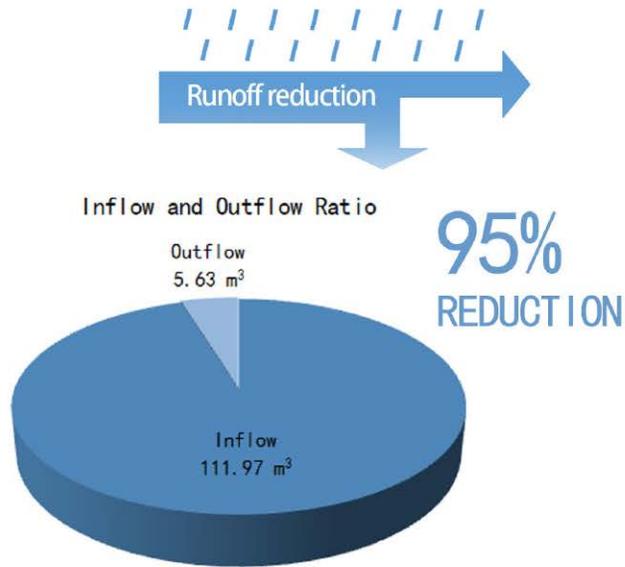
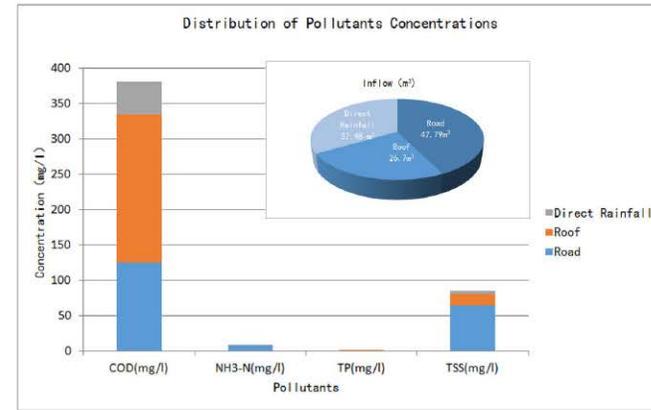
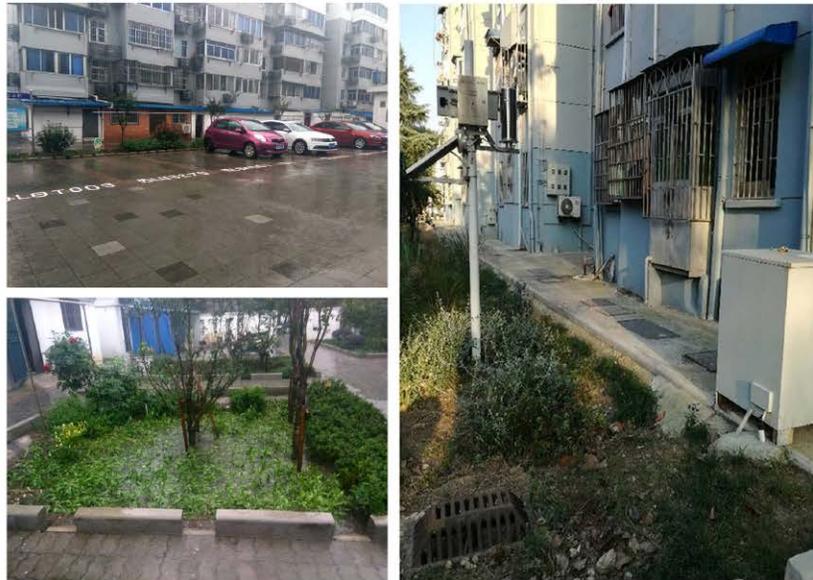
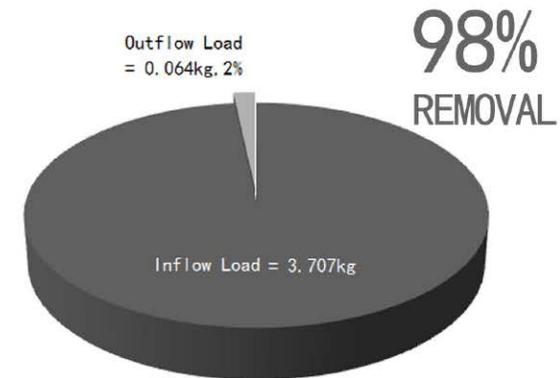
15 Performance Evaluation

Land Use Type	COD (mg/l)	NH ₃ -N (mg/l)	TP (mg/l)	TSS (mg/l)	Inflow (m ³)	Concentration (mg/l)	Loading (kg)	Removal (%)
Road	125.09	7.57	0.21	64.73	47.79	33.11		
Roof	209.45	0.26	0.07	16.36	26.7	111.97	3.7073	0.9827
Direct Rainfall	46.27	0.25	0	4.73	37.48	11.36		
Concentration	118.82	3.37	0.11	33.11	111.97	5.63	0.064

Pollutant Load

More than two years of continuous monitoring data showed that 95% of rainfall were detained onsite, and 98% of total pollutant load were removed by GSI.
