Pacific Northwest Salmon Center Belfair, Washington

Landscape Architect:	Bruce Dees & Associates
Client:	Hood Canal Salmon Enhancement Group
Architect:	Miller Hull Partnership
Engineer:	ESA

PROJECT DESCRIPTION

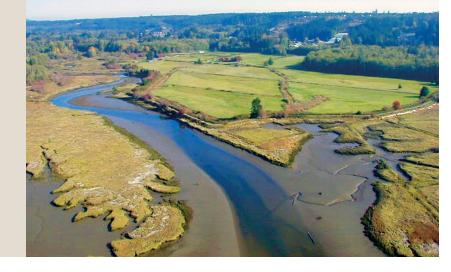
1891 Pre-Dike Conditions Analysis of historical data, including the 1891 T-Sheets and aerial photographs, provided a good indication of the original extent of salt marsh and intertidal zone.

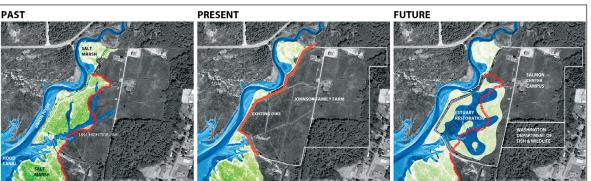
2010 Existing Conditions Current aerial of the existing conditions show the extent of the salt marsh lost to dike construction. This is critical marshland associated with the Union River Estuary.

Post-Reclamation Conditions A new set-back dike will protect the Center facilities while increasing pre-1891 marsh limits. Wet area inside the dike will be shallow to limit access to Salmonid predators.
